Physical Plant Inspection of Comcast Communications in the City of Bellingham, Washington

May 2010

Inspected by
Kramer.Firm, Inc.

**PHYSICAL PLANT SAFETY INSPECTION
OF COMCAST CABLE COMMUNICATIONS
IN THE CITY OF BELLINGHAM, WASHINGTON**

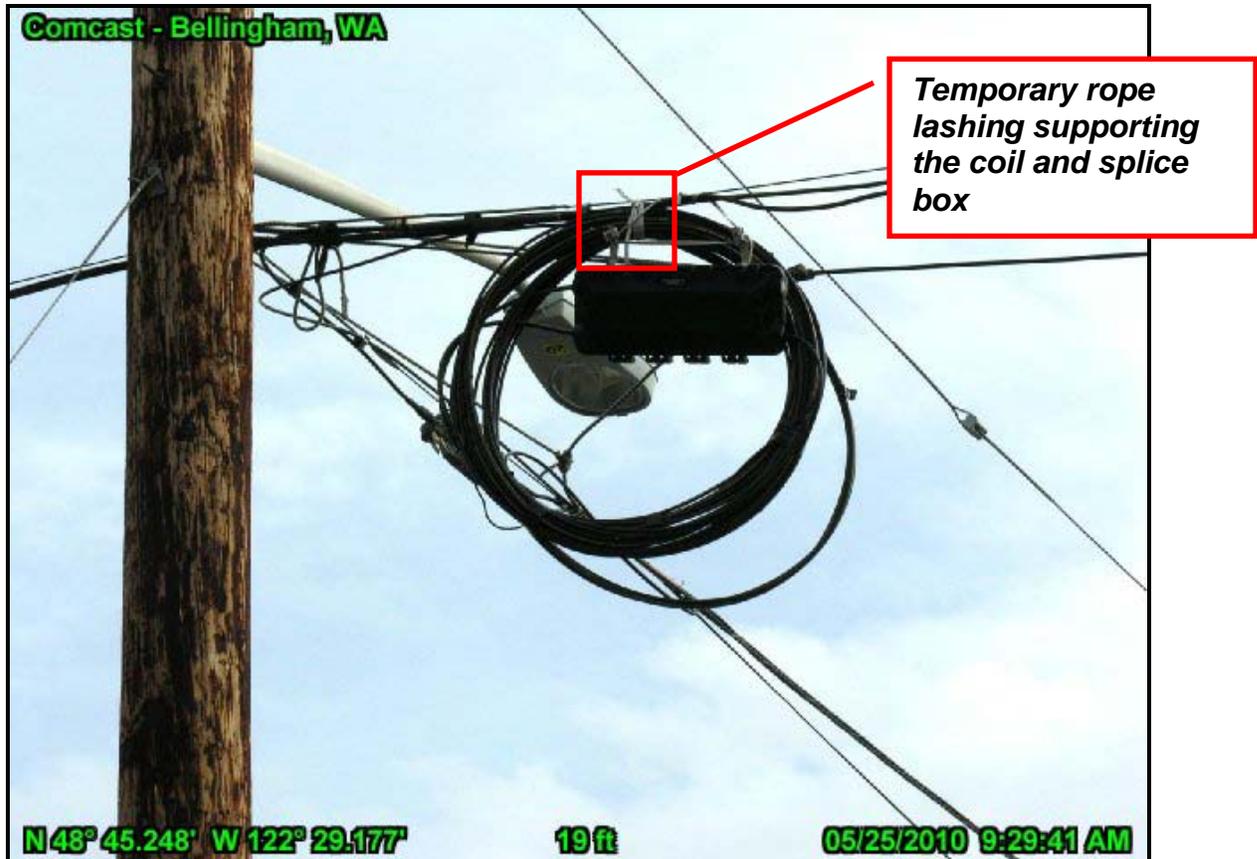
Figure 4: Corner of D Street and Holly Street. Fiber coil and splice box hanging from strand.

Heavy cable coils and splice housings suspended on overhead lines pose a risk to the general public and the integrity of the cable system itself. If the lashings used to attach the temporary equipment to stand should fail, the falling equipment could cause damage to objects and individuals below. Conversely, if the strand is not strong enough to support the equipment, the weight of the hanging equipment may cause the strand to sag or break.

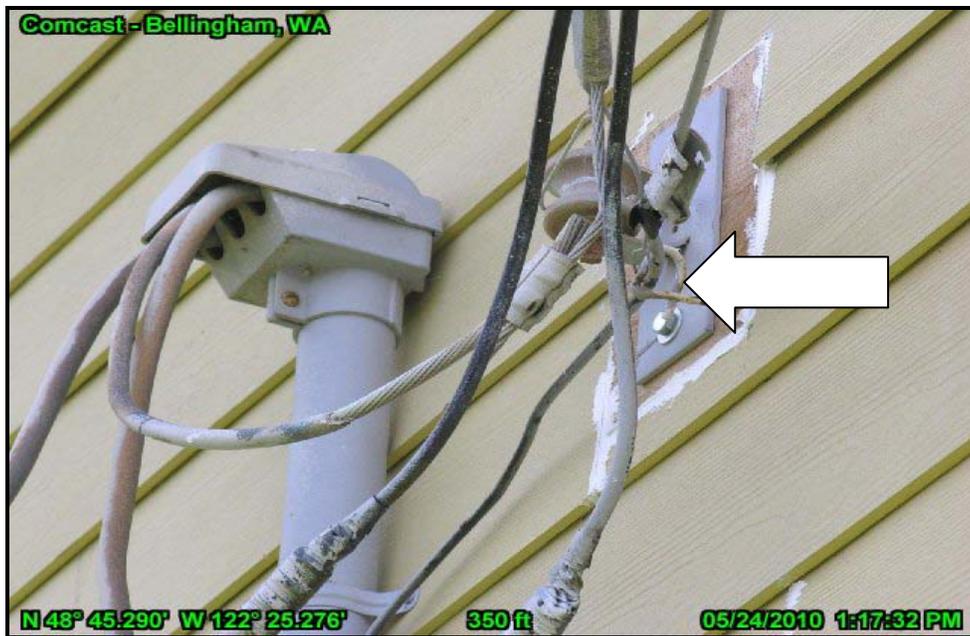
Figure 8: 1901 Ohio Street. Cable drop is installed at same point as power. Clearance violation of separation rules in NEC.

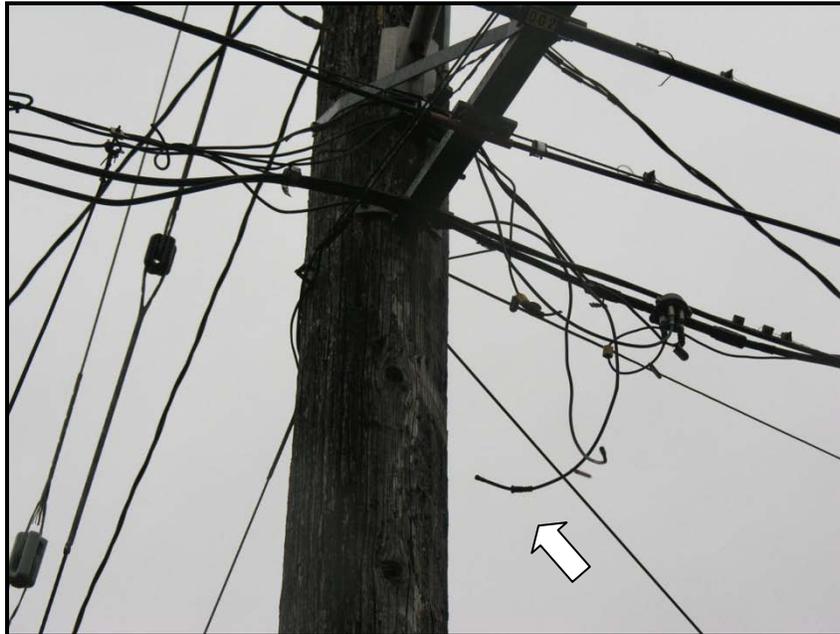
Figure 15: Loose unused cable hanging freely from overhead pole

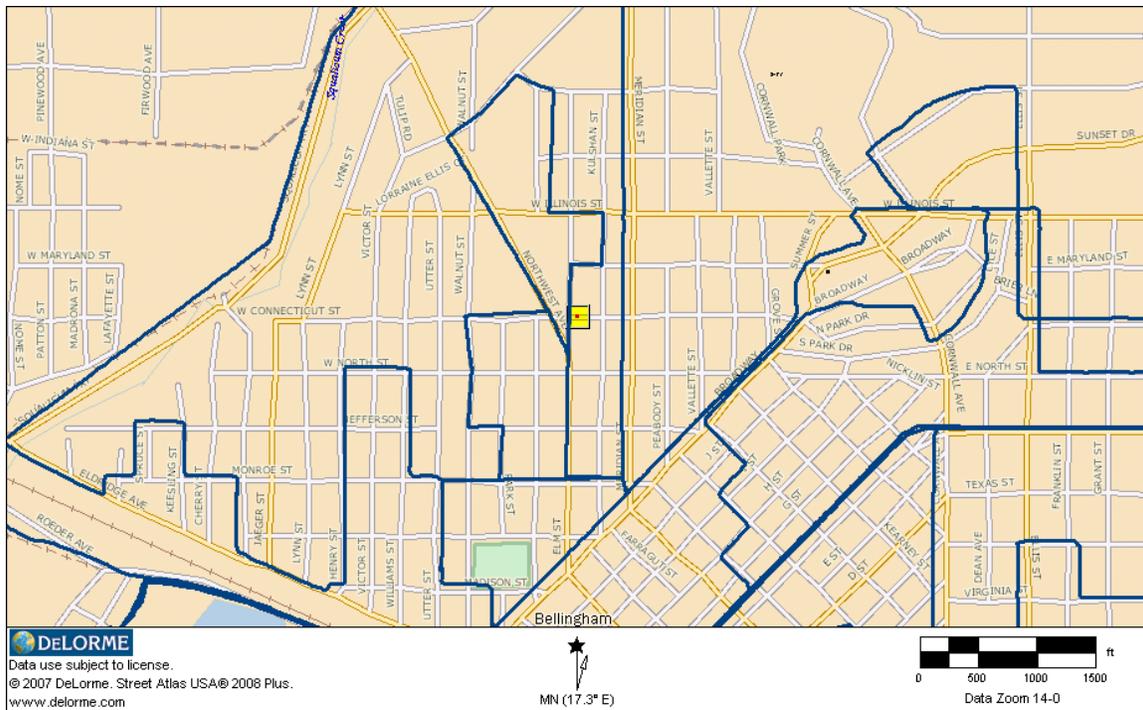
2823 Elm Street. Cable drops hit the power mast, wiring ty-wrapped to the power Mast conduit. Ground wire not secured.

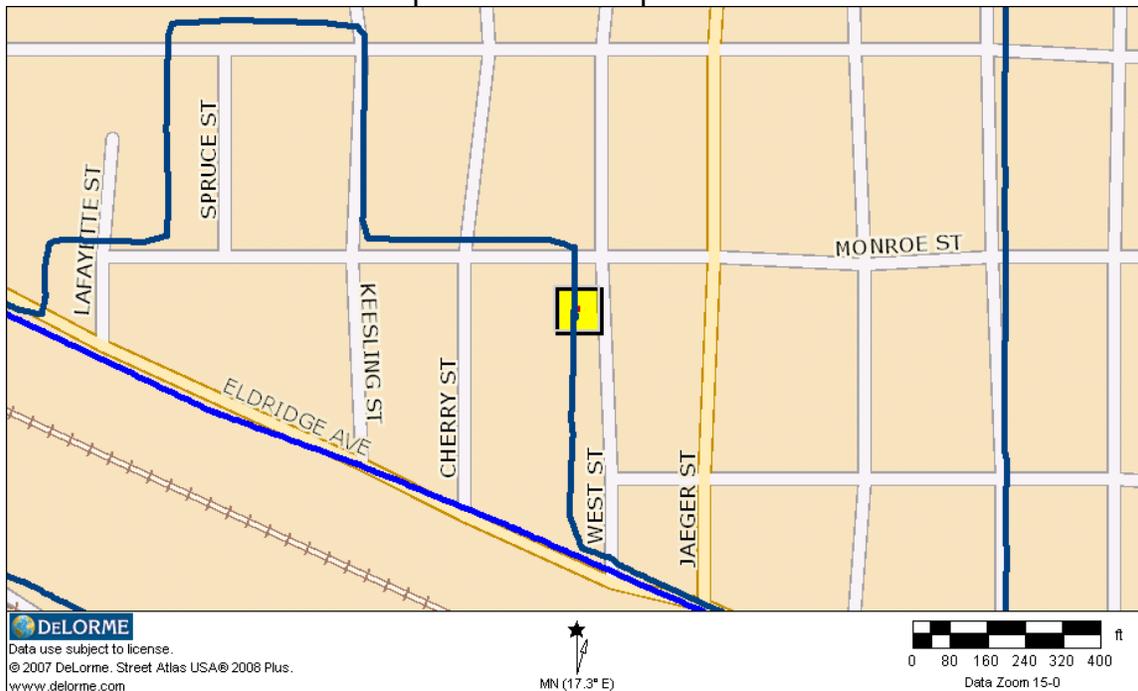
2339 West Street
Drop attached to the power mast

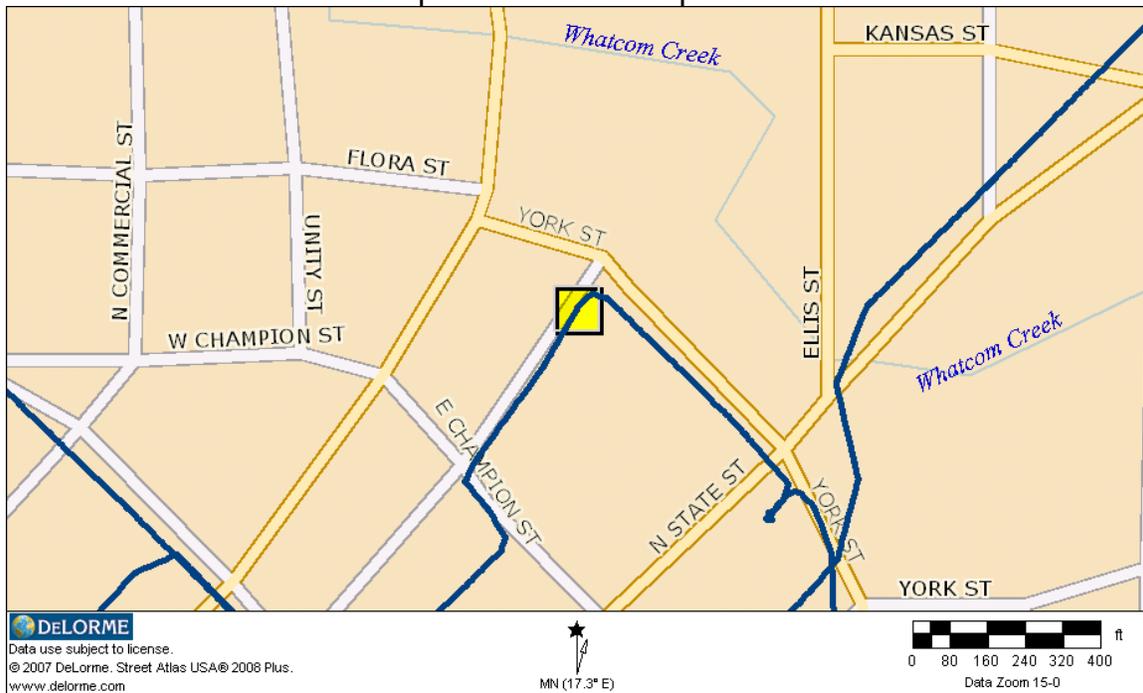
Corner of Railroad Ave and York St
Fiber optic enclosure tied up to strand.

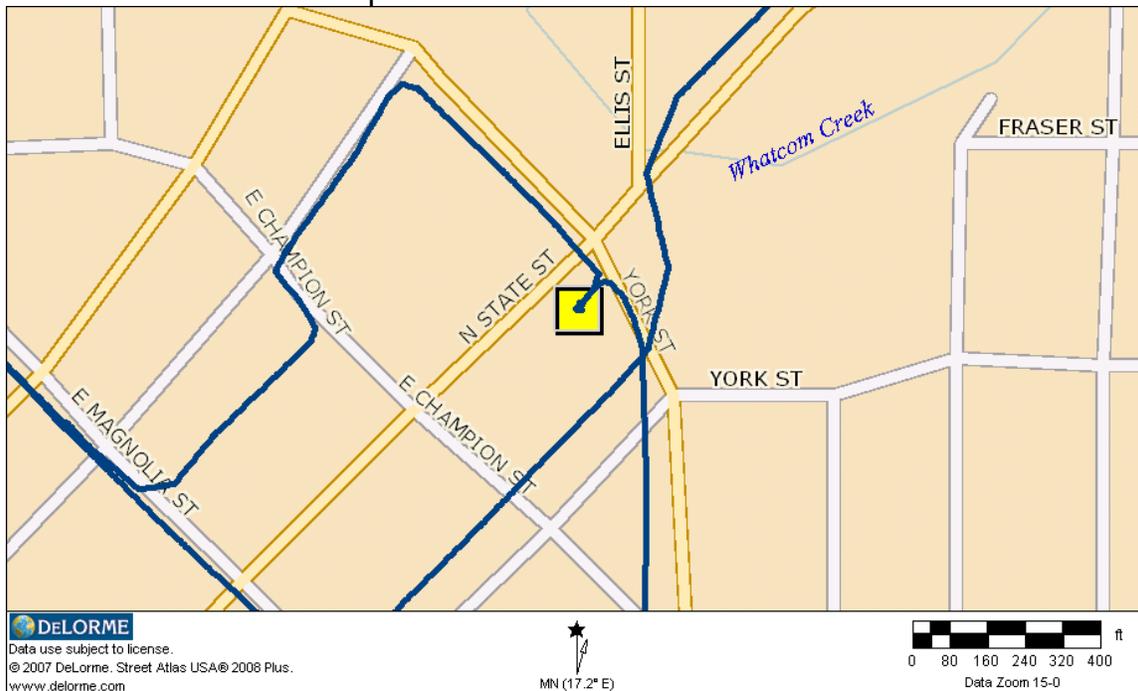
Next to the Firestone store on North State Street.
Fiber optic enclosure and cables tied to strand.

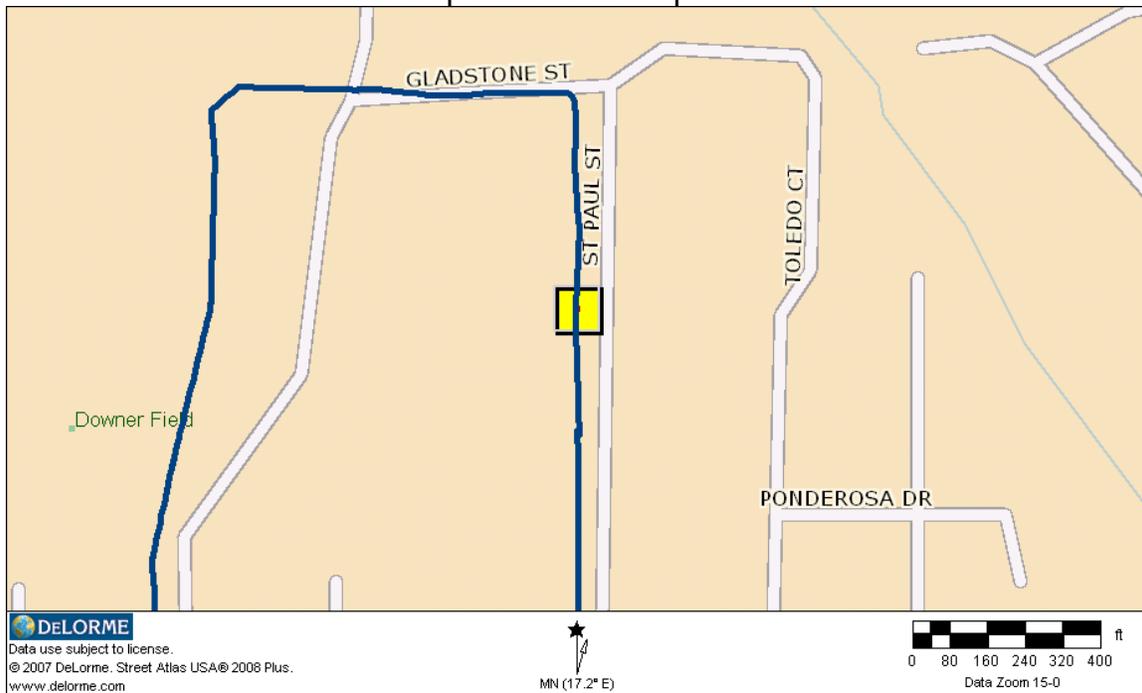
Cable drop attached to the power mast.

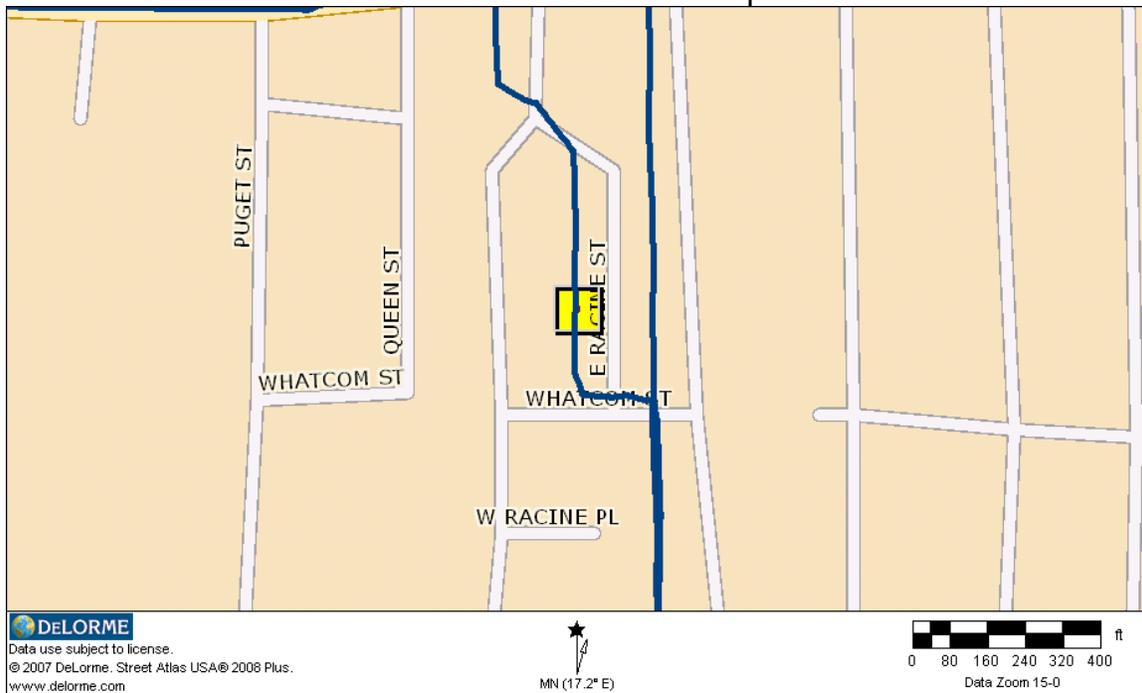
1213 East Racine Street.
Riser cables not secured to the pole.

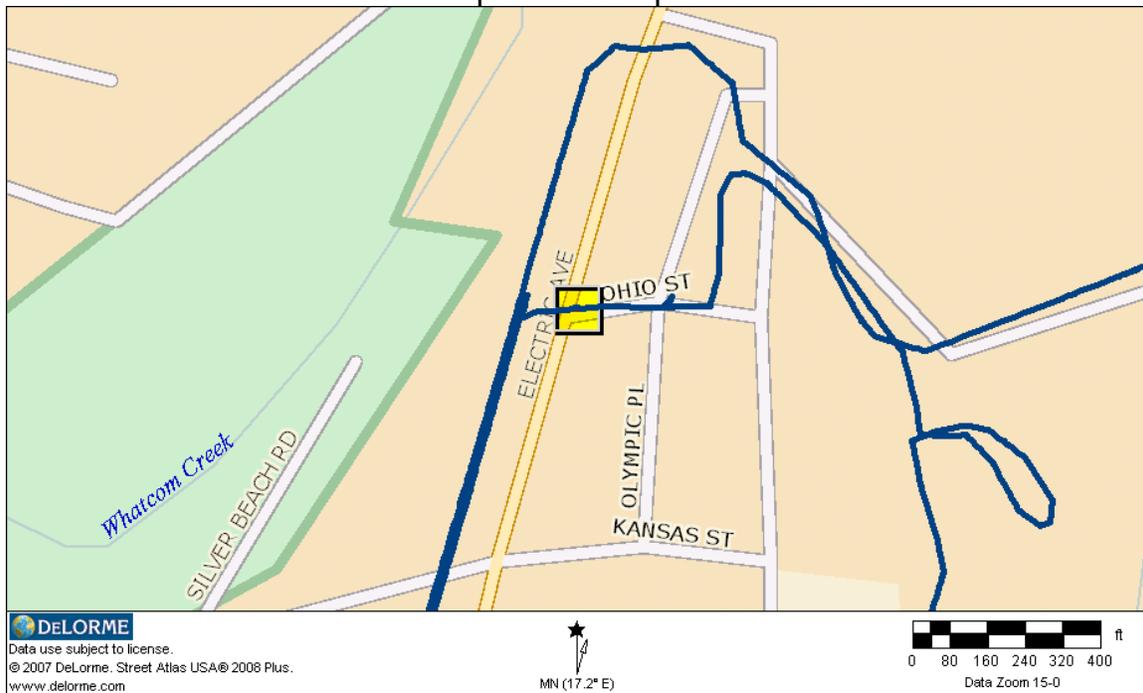
Corner of Electric and Ohio Streets
Cable drop attached to power riser

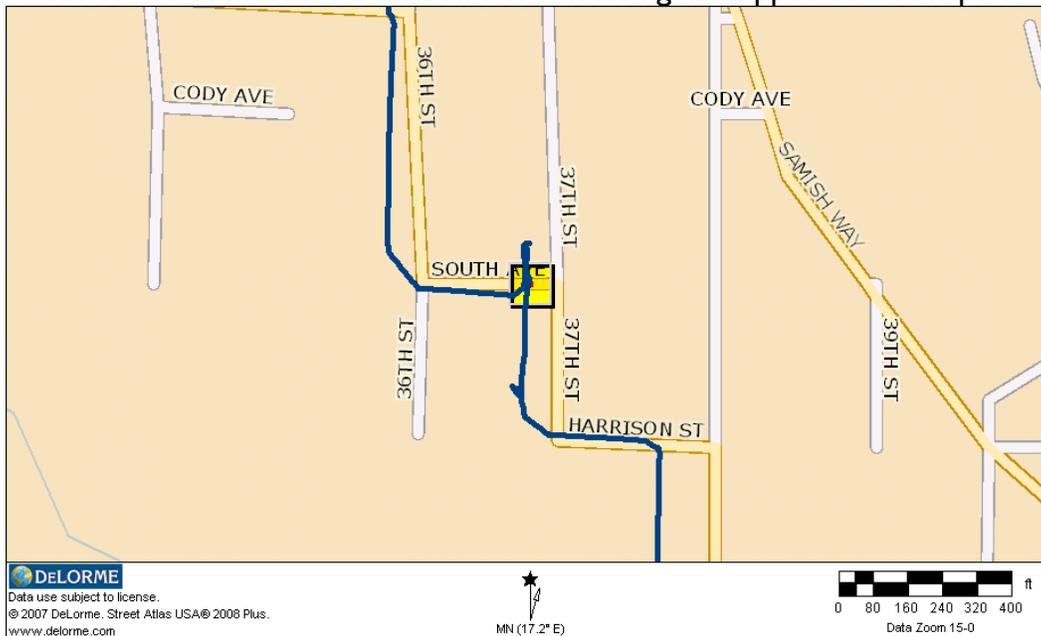
Poor pole change out. "Preforms" and deadens not properly attached.
Cables and connections not shrunk. Shrink tubing has slipped down the pole.

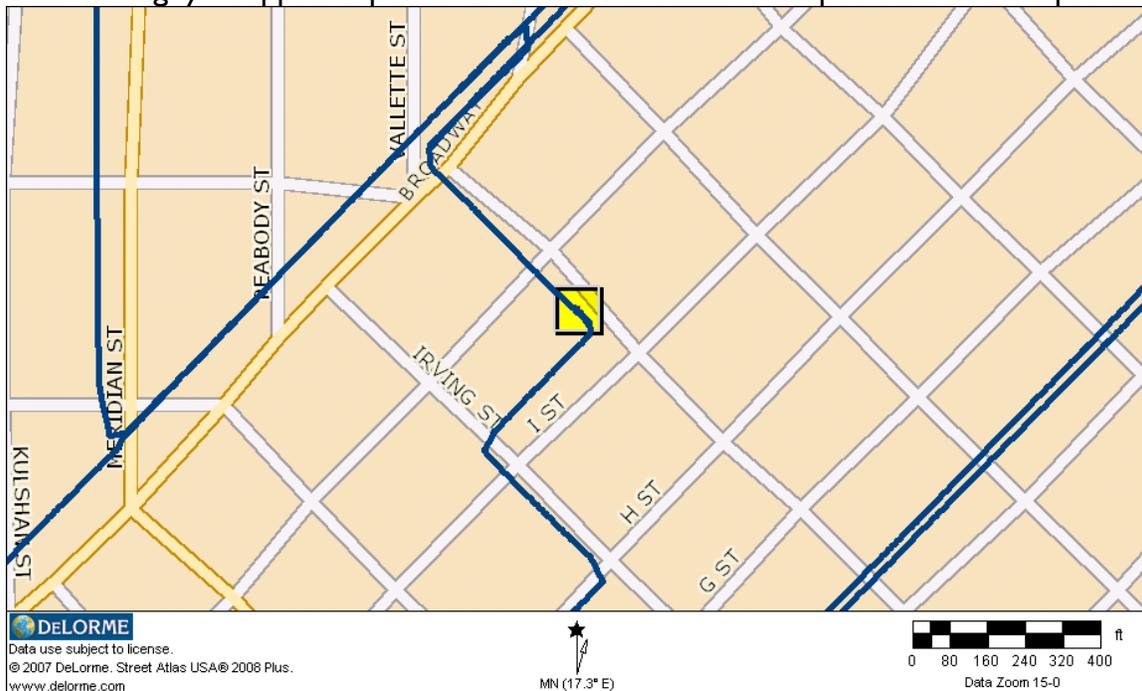
Cable wiring ty-wrapped to power riser conduits. Attachment point too close to power.

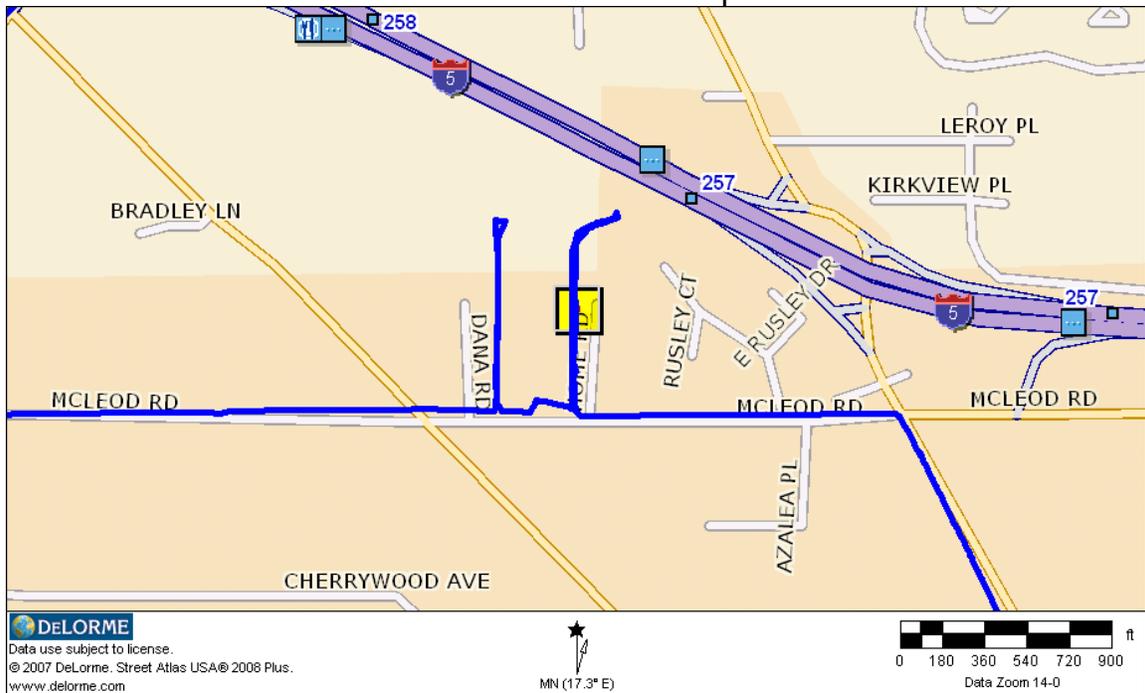
3624 Home Drive
Cable riser not attached to pole.

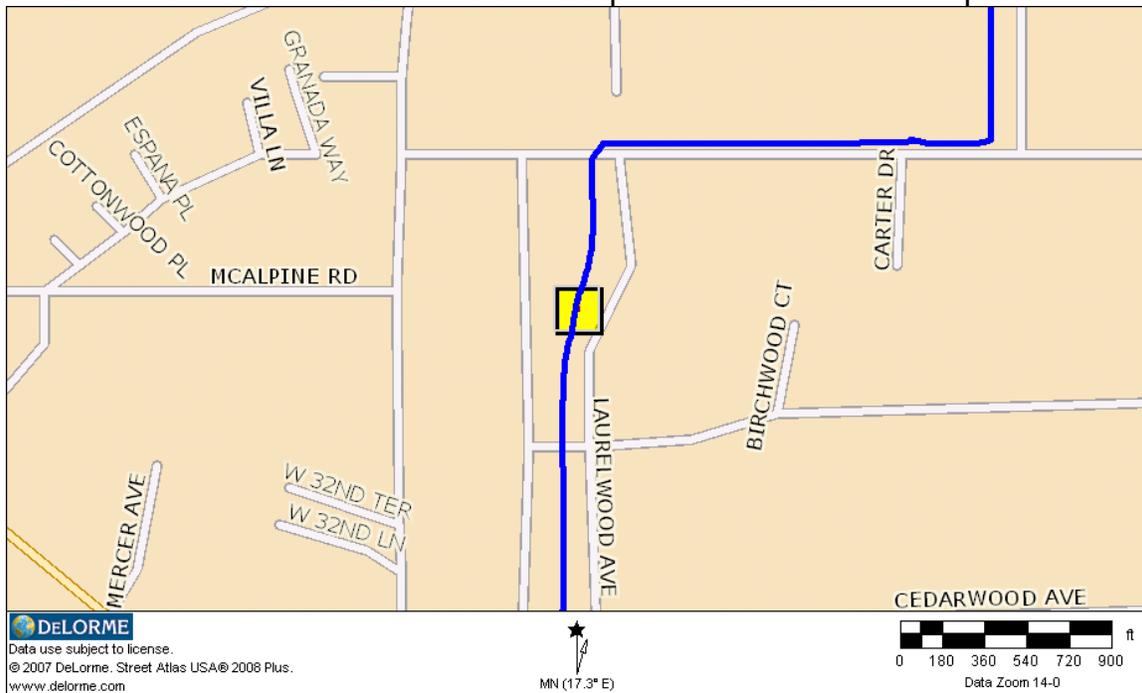
Cable strand mounted too close to power transformer and drops.

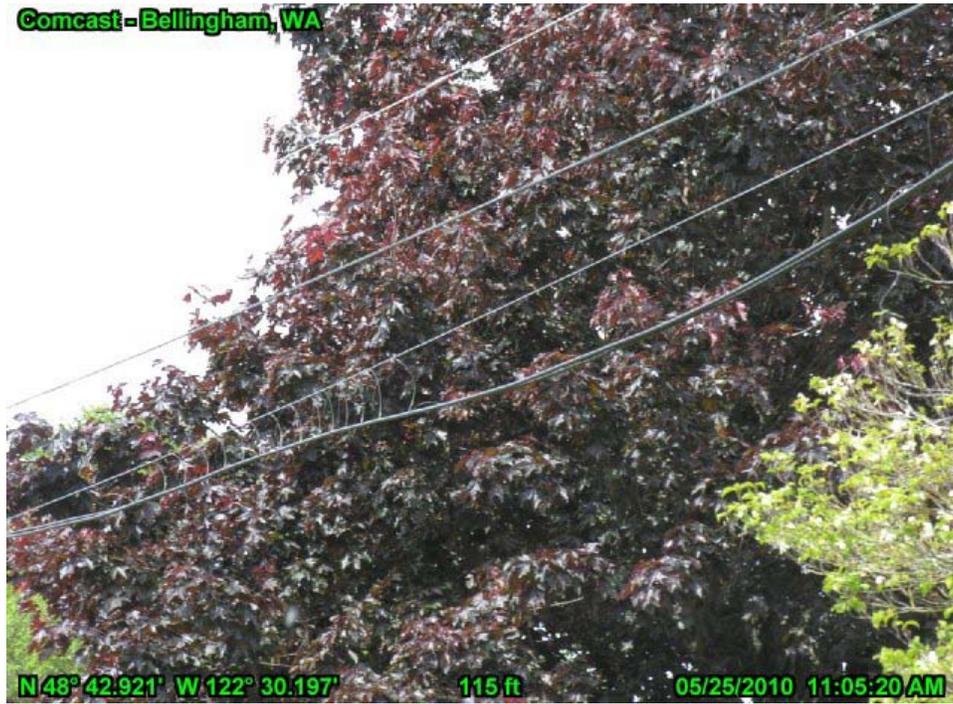
510 Everglade Road
Drop riser not secured to pole.

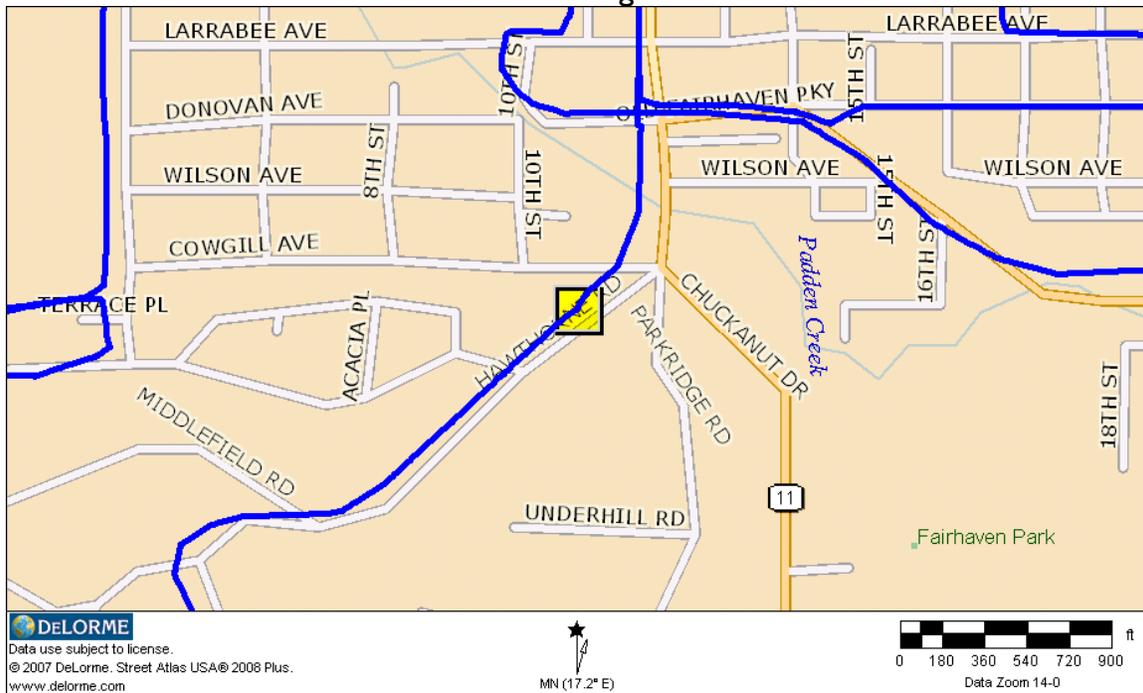
93 Hawthorn Road
Broken lashing wire.

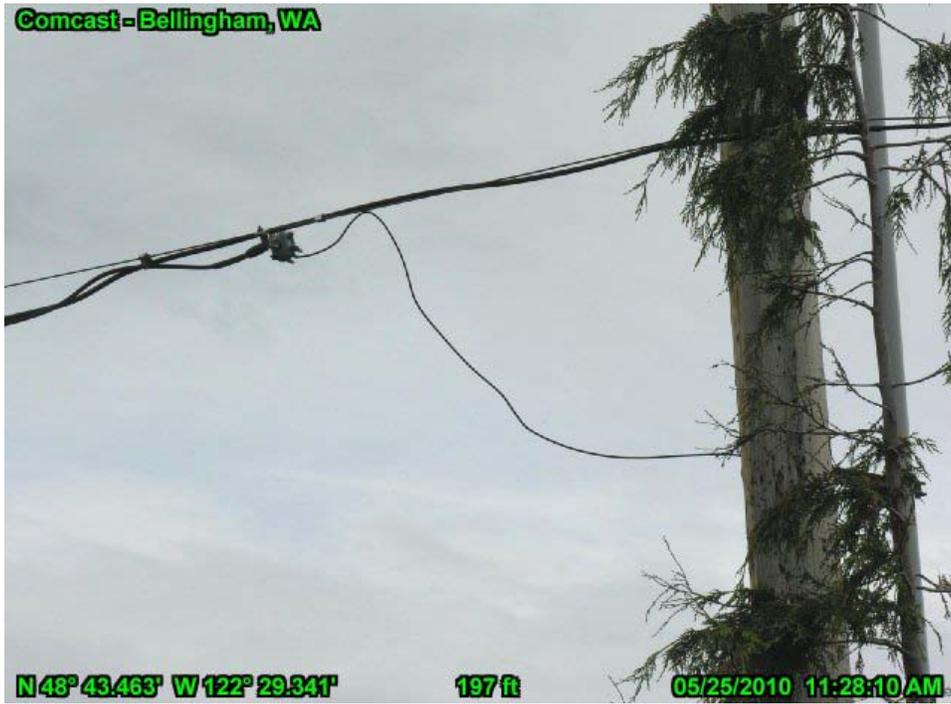
917 to 927 - 22nd Street. Damaged cable sections. Broken cables, lashing, taps.

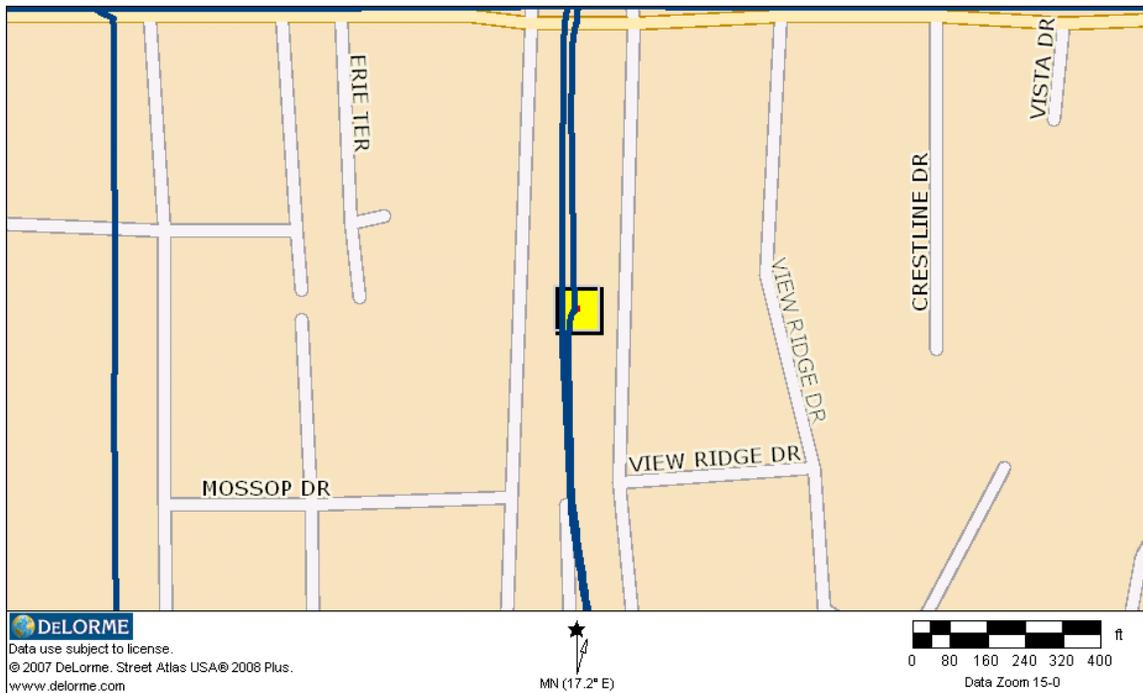
2325 Vining Street. Cable drop attached to the power mast.
