January 17, 2020

Subject: Letter Report Geologically Hazardous Area Site Assessment Proposed CityView Suites Development Bellingham, Washington File No. 22191-002-00

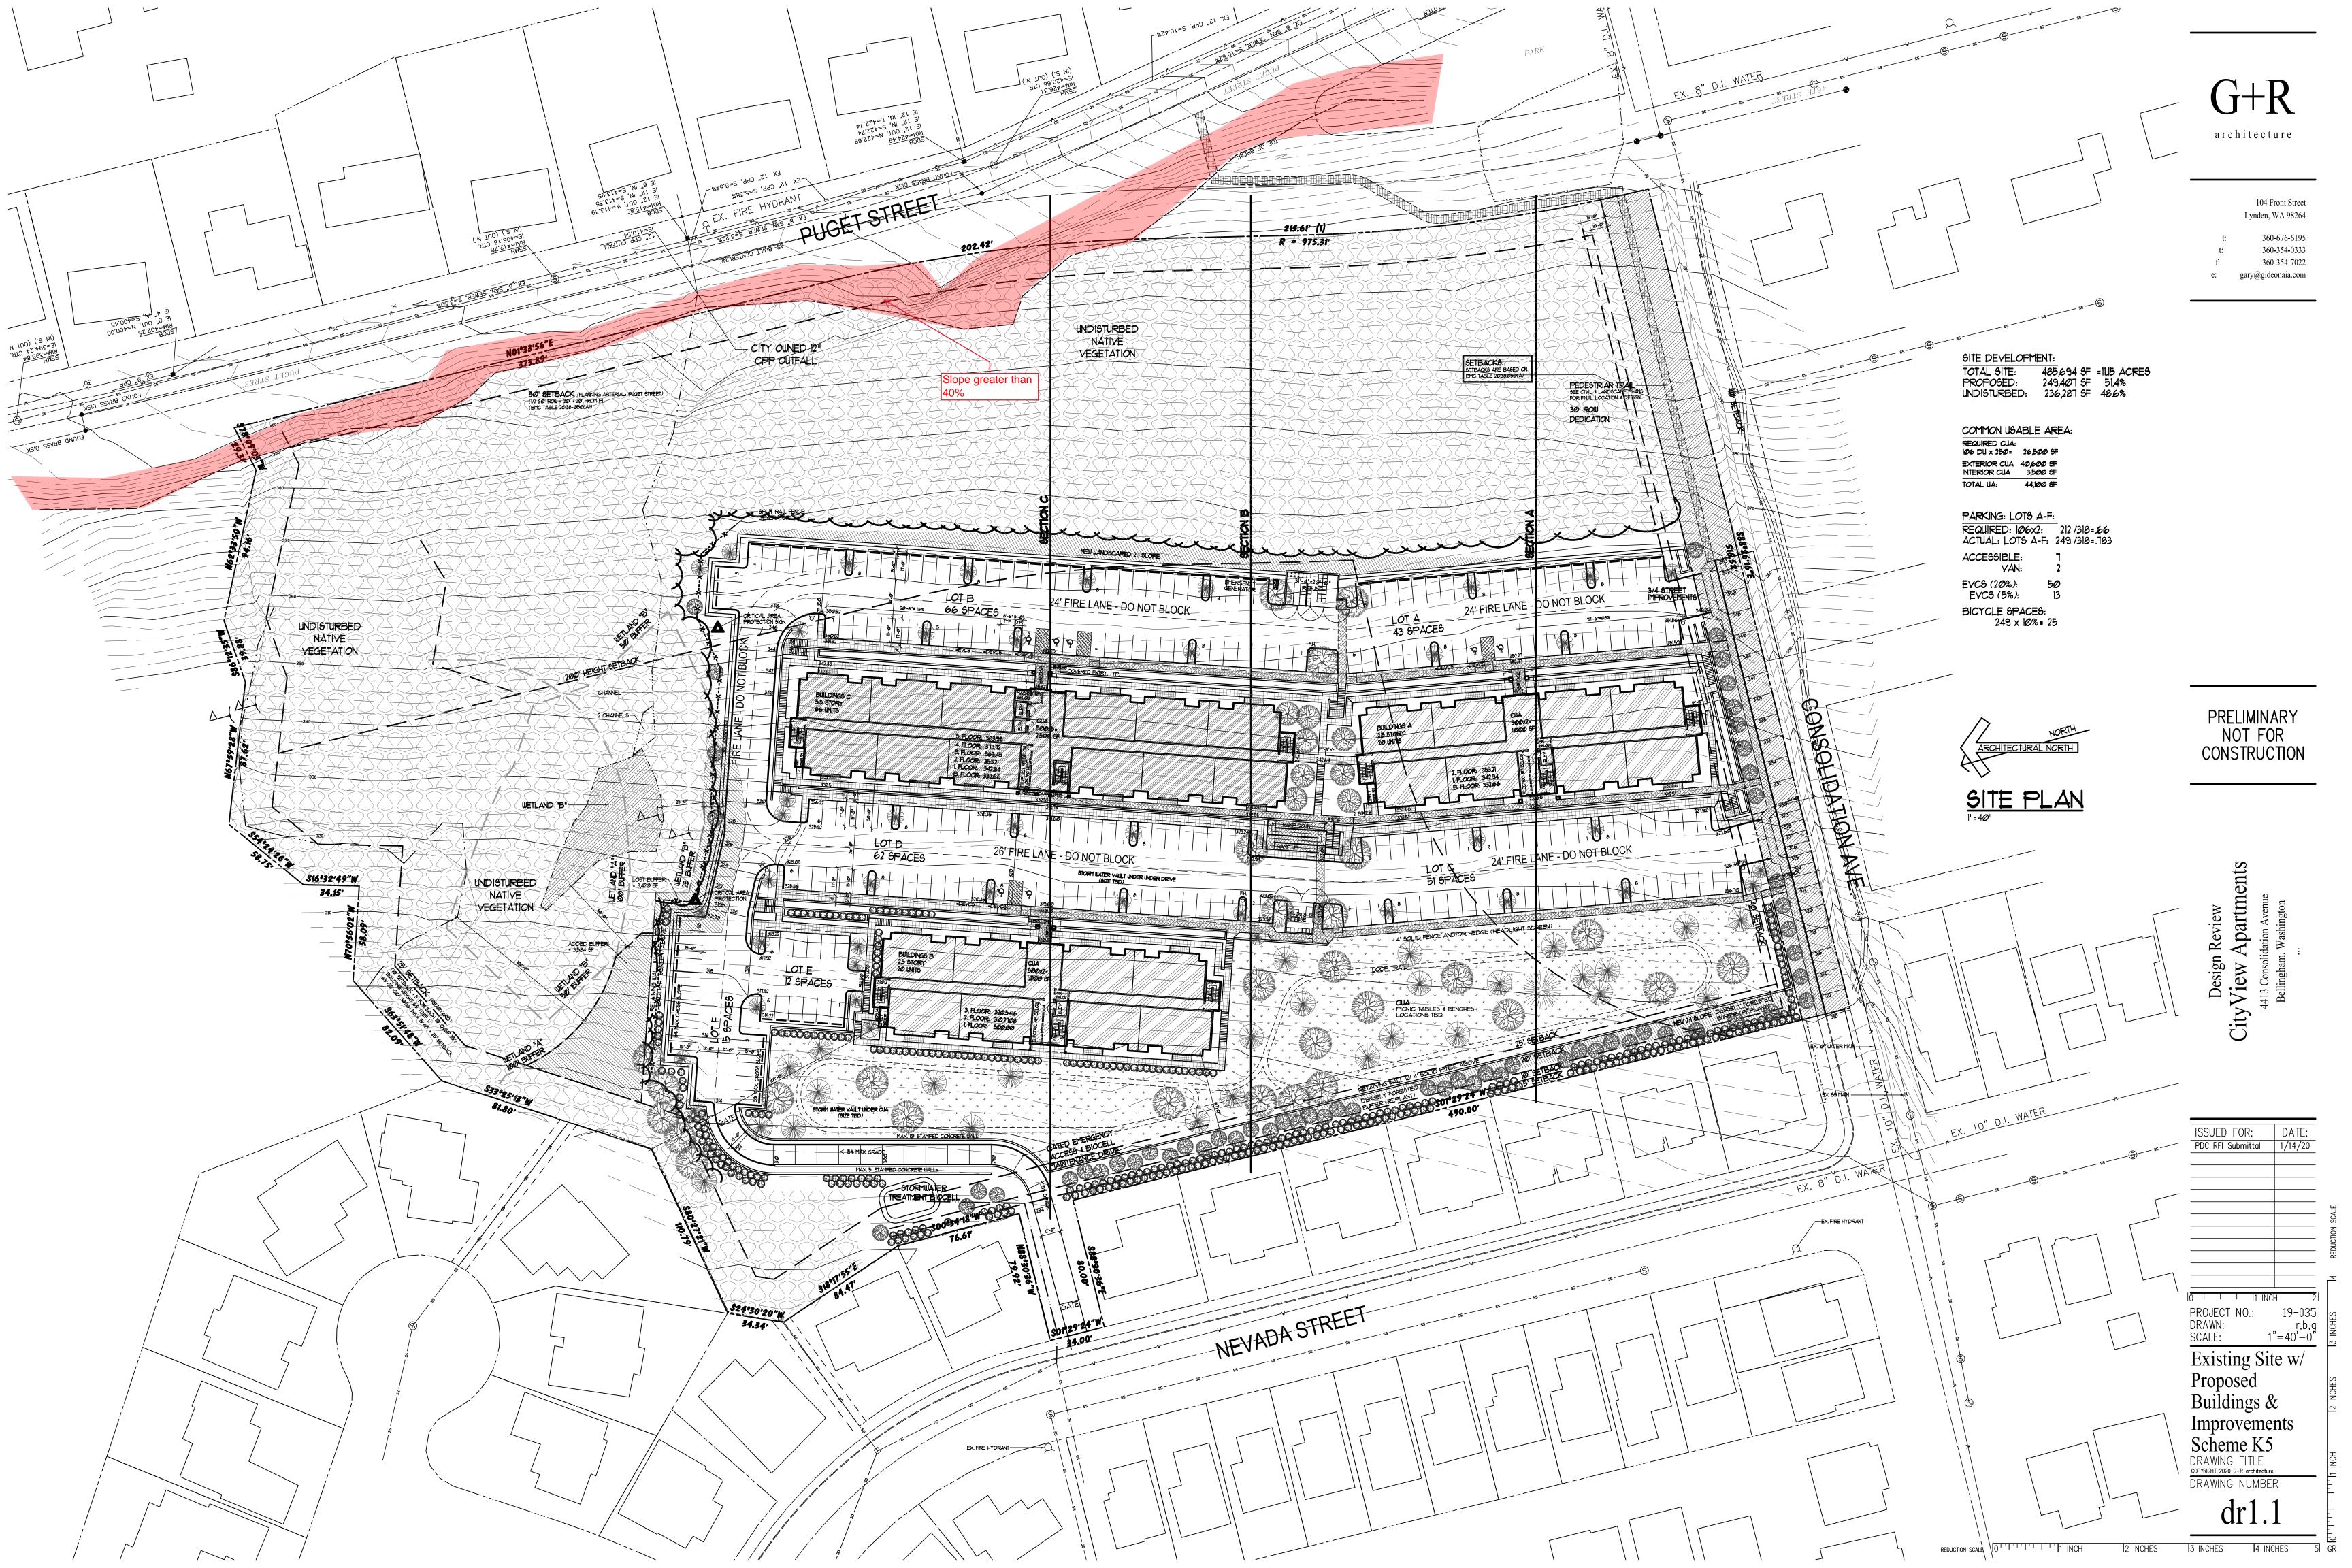
The 11-acre site has a typical slope of 20 to 22½ percent downward to the west. This is flatter than the steep slope criterion per the CAO. However, a thin band of steep slopes greater than 40 percent is located along the east margin of the site and extends into the Puget Street right-of-way (ROW) as shown in attached Sheet dr1.1. Based on our observations, this steep slope is a result of former grading to construct Puget Street and likely consists of fill soils.

No significant evidence of slope instability was observed on the slopes at this site. The critical slope is covered with thick growths of understory vegetation including blackberry brambles. Natural groundwater springs are mapped at the site in the City Geologic Hazard Areas Map Folio, which likely correspond to the drainage areas and wetlands mapped as shown in the attached GR Sheet dr1.1.

The hazard identified is the steep slope along the east margin of the site, which consists of fill from the Puget Street ROW. The proposed site development will maintain an offset of at least 140 feet from the steep slope, which exceeds the 50-foot buffer per BMC 16.55460 A.1.a. Therefore, impacts to the steep slope identified are not anticipated.
