Item 4.0 of “Adapting Woodstock” Charrette “Site Planning Topics & Reference Items”

Working With Water—Wetlands, the Creek, Bay Dynamics

Notes and Map by Tim Wahl, July 2008

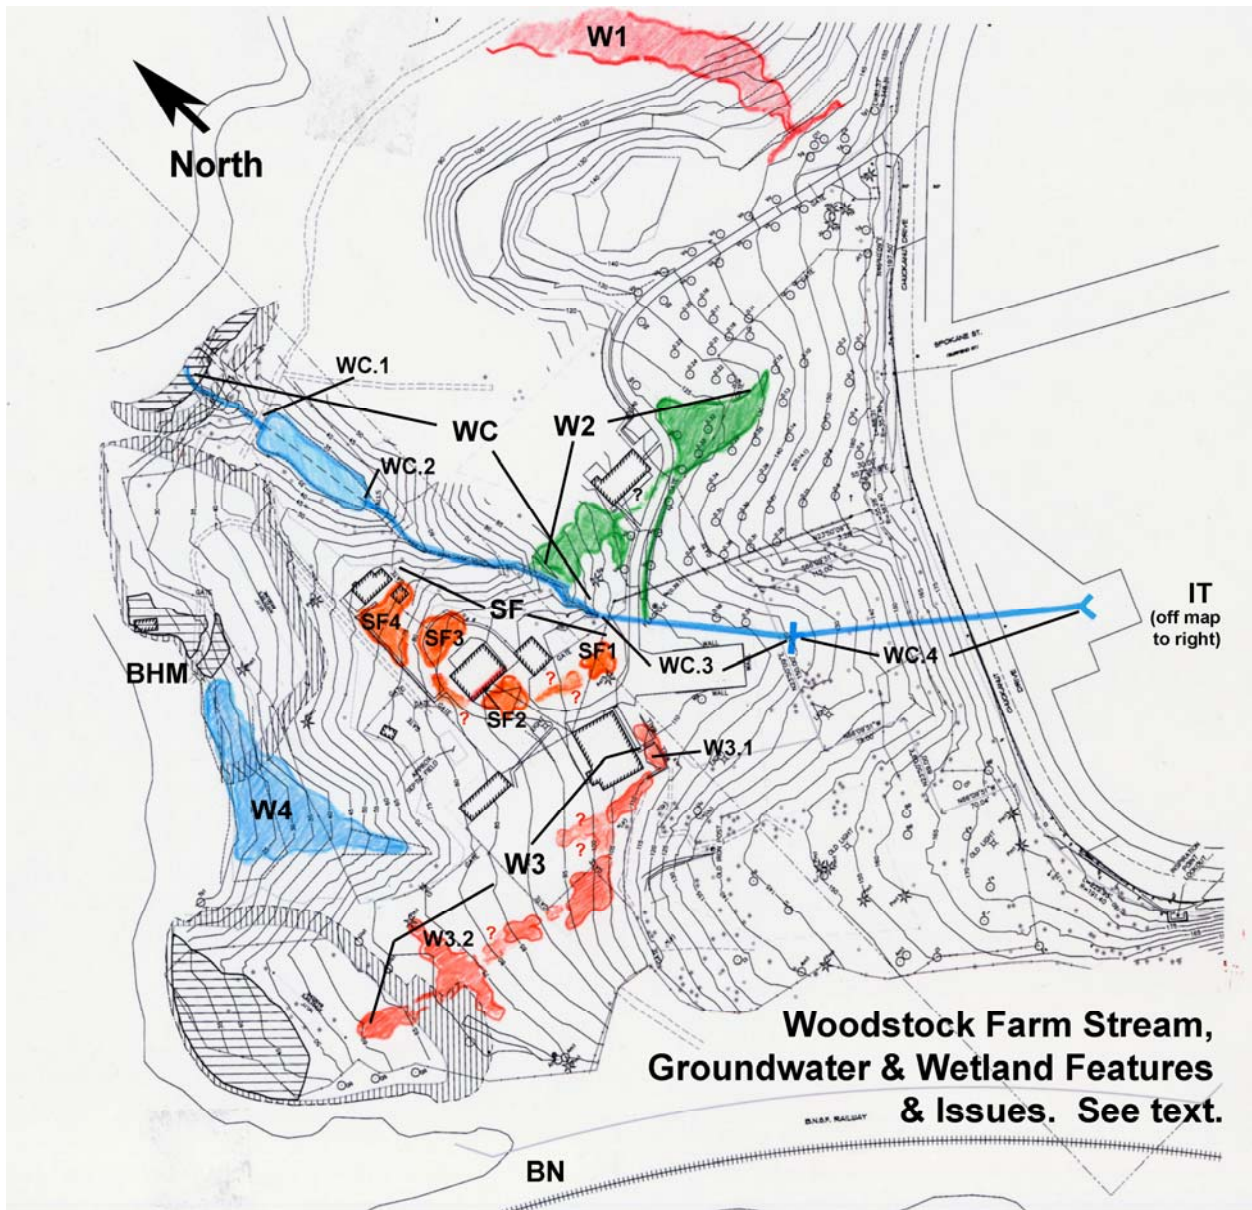
W1 Kopperdahl Wetland; Trail Renovation Issue

The switch-backing trail here is a former cat road constructed hurriedly by aspiring developer. Trail renovation requires a drainage system that essentially incorporates the hillside wetland flows moving down the draw. Like other narrow, forested wetlands this feature adds considerable biological diversity to the Woodstock site. This wetland should be protected and must be “worked with” creatively to dry-out the trail. While a few species could be added to enhance diversity, based on appropriate reference sites, the understory and herbaceous components are in good shape and fairly diverse.

Water collects in the mowed basin opposite and E of the Cook’s House and is apparently discharged in a (probably partly collapsed) tile to the Cooks House wetland. The basin above the driveway has been historically grazed and altered (probably drained with tile) since the 1910s; as modified it comprises an important part of the historic character of the maintained orchard and grounds. Creation of a vernal pool could be explored. Water can be heard flowing from inside the Cook’s House basement. A portion of the peak discharge, probably resulting from tile failure, now flows along the upper edge of the driveway to and inlet at the sports court parking area, where it enters the creek culvert, one assumes. This flow along the driveway is likely charging the subgrade of the driveway, an undesirable state of affairs that should be corrected soon.

Replacement of G-L House perimeter drains could eliminate a wet lawn problem at front door (W3.1, unusable during wet periods) and to relieve potential long term issues involving the house foundation... *Iris missouriensis* planted 2008 in pasture pockets W of “Chicken House lawn.” These seeps might be developed into wet meadow pockets and vernal pools as part of a designed landscape, for floral and biological interest. This system has been historically grazed and altered since the 1910s and, as modified, comprises an important part of the historic character of the Farm’s cultural landscape. Grass tennis court (W3.2) needs perimeter drainage for sustained use; it may have had such a system when constructed. Wet meadow pockets are visible outside regularly maintained areas cueing to *Juncus*. Preservation and enhancement of vernal pools and management of groundwater flows moving toward the extremely dry

A relatively high quality forested wetland. Himalayan blackberries being removed from drier edges. *Viburnum trilobum* was added to buffer area. Former Gates' access road to the 1920s floating boathouse ran down this draw. Prehistoric wet-site artifacts of great interest but none found along OHWM. *Salicornia* and *Juncus* marsh at OHWM. 2006 inspection and dye tests with WCH Dept. indicate no septic discharges to this draw.

The Creek runs 6-9 months a year, and is valued as a source of gentle white noise and as a wildlife habitat feature. The potential for salmonid habitat is probably not significant; even with dam removal channel gradient is relatively steep, flows are low and fluctuating and a fish-impassible waterfall lies about 175' above the marine shoreline. The creek was culverted under Chuckanut Drive in 1953 or 1954 when a timber highway bridge was replaced with today's fill. A 36" culvert under the highway now connects with a 12" culvert running along the NE side of the sports court parking area to discharge into the open creek channel at the edge of the driveway. The discharge area below the driveway was seriously eroded during a creek overflow incident during the 1970s or 80s (?) when an object passing under Chuckanut blocked the 12" culvert in the junction box just above the sports court parking area. The eroded slopes at the 12" culvert discharge, while requiring stabilization, have remained remarkably stable after the overflow incident. Denis Bailey speculates there may be more than one culvert under segment WC4, although only one discharge is known. It is possible that an earlier Gates culvert under the original kitchen garden failed and was replaced by a second line by the Lees at the time of the 1953 highway construction. Apparent subsidence around the monkey-puzzle tree suggests underground instability due to ground water movement. Bailey has also wondered about a possible connection between the S barn wall and slab failures and old creek flows or flooding incidents.

register type management approach for the Farm. While attractive, integrated actions are desirable for all of WC4 it must be emphasized that the driveway culvert portion itself is at some risk of failure, along with the effects of surface water flowing along the driveway from the upper part of W2, the Orchard Spring...an artistic timeframe may be unwise at the driveway.

WCD Lee-era creek dam installed for fish rearing and aesthetics. Reservoir is now severely filled with fine sediment. Impoundment pool and waterfall are nice aesthetic features during high water. Dam removal assistance grant funds are not suitable due to lack of fishery. Giant salamander (nearby occurrence) habitat value of created pool should be examined. Dam is probably in best location for improved footbridge, a function it now serves. Pros and cons of removal, replacement, maintenance etc. all need study.

Integrity of the Interurban rail grade fill and the condition of the culvert there (both owned by Puget Sound Energy) have been identified as a concern in the event a seismic incident combined with rainfall. There appears to be no functioning culvert under the old rail grade fill, which impounds water during wet weather and where an upstream wetland has formed over successive years of inundation. Of note is an event like the "Fire Hall Flood" father south on the Interurban grade, which threatened flood and debris torrent damage to Chuckanut Drive and several residences.

The concrete slab in front of the barn is failing and the S foundation wall of the barn basement is leaning to the N. Two structural engineers have looked at the situation and suggested monitoring. One felt action was needed immediately. Crack monitors are now in place on the barn wall, and indicate no movement over the past 18 months. (No failure trends or actual incidents are known.) Hydrostatic pressure is most certainly the cause of the barn wall movement, something which needs to be mitigated with sealing of the adjoining slab ASAP. Denis Bailey has speculated that there may be subsurface water movements from the old creek channel below the sports court parking area toward the barn slab/wall failure area. He also made note of the fact that the slab failure seemed to come after the plugged culvert incident described under WC, above. (Parks crews are implementing temporary water infiltration prevention actions this summer.) Taken with subsidence observed around the monkey-puzzle tree just N of the Gates-Lee House

and slumpage and soil heaving below the barn it is advisable to consider connected groundwater movements that may be influencing the entire S creek bank from the monkey-puzzle tree to the Cowman's Cottage. Below and N of the barn the old Gates dump (SF3, paved with a slab for parking by Ray Lee) is visibly slumping, the Cottage walkway slabs are heaving and an old shed at above the Cottage is breaking apart. Groundwater movements in this corridor are essential to understand with respect to the present septic fields in the area, as well what they mean for development of a new sewage treatment system elements for publicly-adapted Farm buildings.

The loss of reflected wave energy from the N Bay shore, whether as an eddy or as direct counter waves, is apparently the main reason the midden bluff at the Lee boathouse is eroding. Historic photographs show a more gradually sloping, vegetated bluff at the boathouse and eyewitnesses over the past 40-50 years report a significant increase in undercutting and sloughing of the culturally deposited bank material. Perhaps a shoaling of the adjacent basin due to sediment accumulation has also changed the way wave energy affects the shell midden deposit. The exposure of ancient cultural material affects how the

**Woodstock Farm Stream,
 Groundwater & Wetland Features
 & Issues. See text.**

Surface and groundwater greatly reduce the usability of the Kopperdahl Trail, an important element of a recreational loop trail for Farm users. Reconstruction of the old road grade as a well-drained trail is essential in places where it crosses and conveys water flowing through the forested wetland there. Wetlands contribute to species diversity and enhance wildlife utilization, if these themes and values are important in the public's use and enjoyment of the site preserving and enhancing wetlands is also important, even for small wetlands retained or enhanced in their culturally modified condition. Problems with groundwater and poorly managed surface water visibly and audibly suggest impending structural problems involving the Cook's House, Barn and Cowman's Cottage and the Woodstock Creek culvert under the driveway. Perimeter drainage around the Gates-Lee House is desirable, but no problems are evident other than a periodically unusable front yard/gathering area. The Woodstock Creek dam is well-located as a pedestrian bridge crossing and creates a reflecting pool for visitors; its effect on fish and wildlife is unassessed and may not be significant and its structural integrity is unassessed. NE Chuckanut Bay is filling in due to changes following construction of the mainline railroad causeway. Rowing and boating access are restricted due to this shoaling and small boat trips must be carefully planned. Shoreline stabilization and covering of the exposed midden face is needed at the Boathouse Beach to permit regular public access and protect the cultural feature. Understanding ground water movements is likely critical to engineered sewage system development. Puget Sound Energy should be energized to manage potential risks associated with the Interurban Trail (rail grade) fill placed across the Woodstock Creek ravine.
