Whatcom County Nearshore Habitat Restoration Prioritization

Prepared for: Whatcom County Marine Resources Committee

Coastal Geologic Services Inc.

June 27, 2007

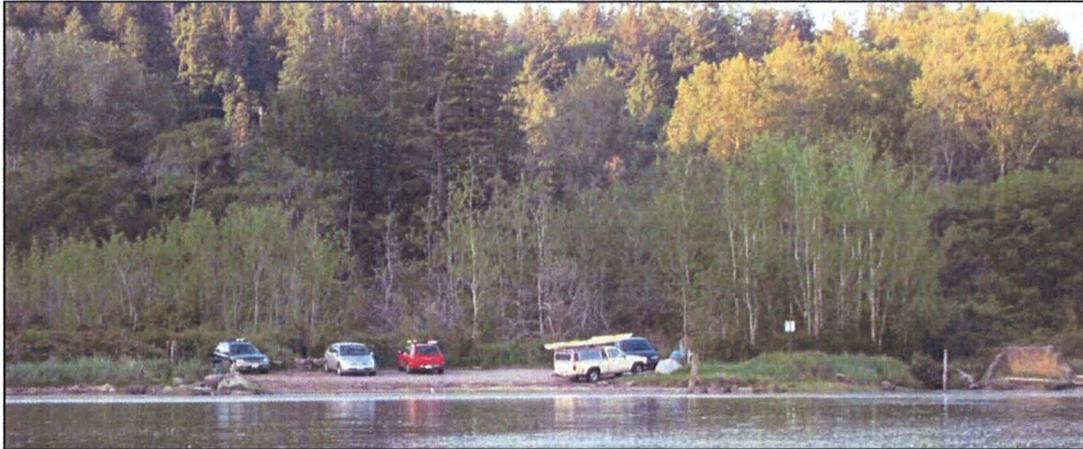
water quality impacts resulting from parking lot run-off could also improve as a result of these restoration actions.

Figure 7. Restore backshore currently occupied by parking lot (CGS field photo).

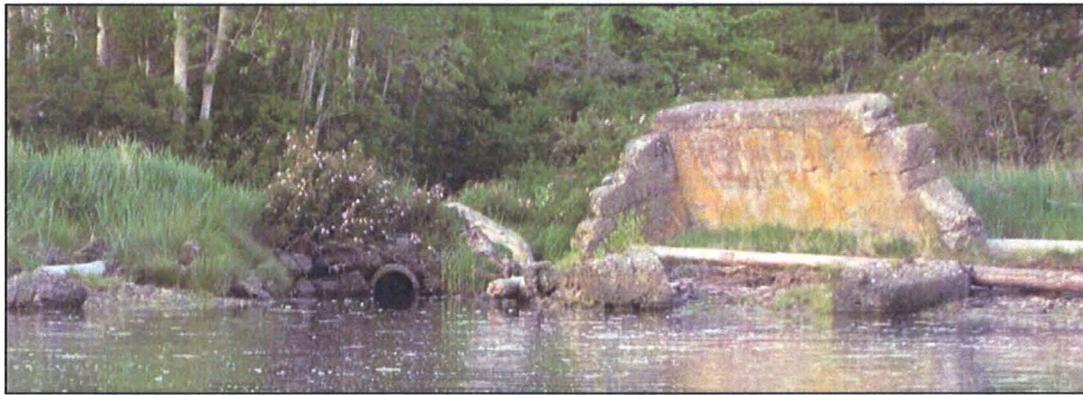
Figure 8. Remove relict concrete structure from backshore and enhance connectivity between backshore marsh/wetland and marine environment (CGS field photo).

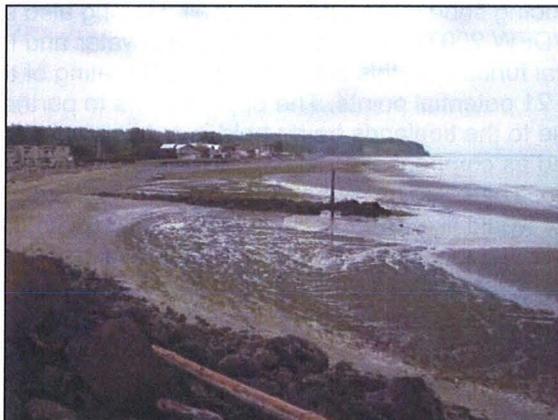
Figure 12. Looking east at armored culvert extending across shore (CGS field photo).

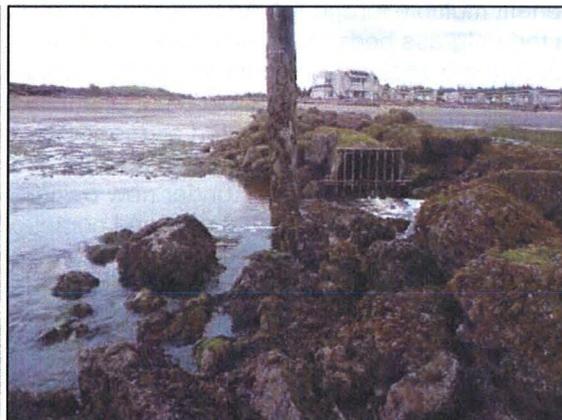
Figure 13. Culvert out-flow with considerable flow (CGS field photo).

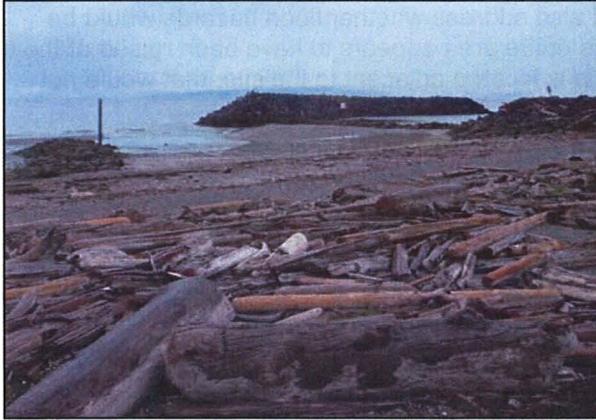
Figure 14. Culvert/stream buried beneath backshore east of Pt Roberts marina (CGS field photo).

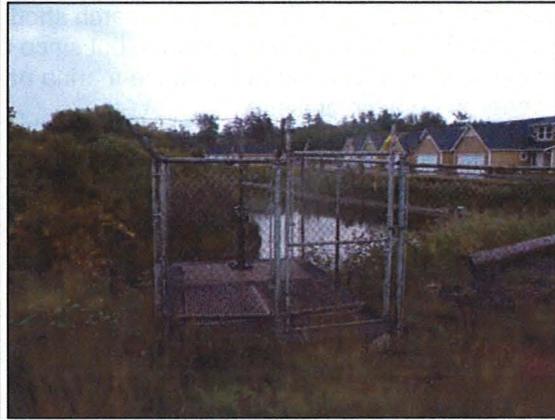
Figure 15. Tide gate and pond drained from Pt Roberts wetlands (CGS field photo).

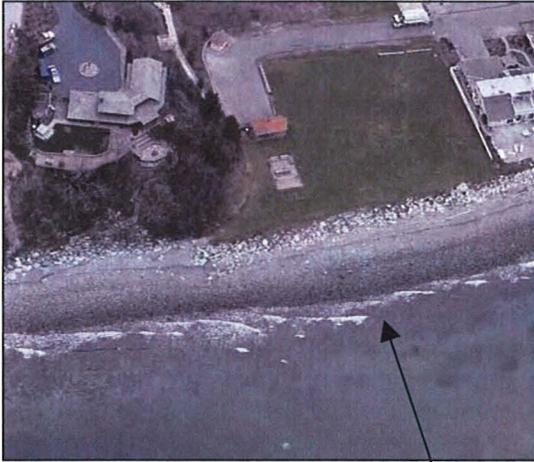
The rockery bulkhead extended well waterward of the adjacent bulkhead to the west and infringed on the upper intertidal beach (Figures 16 and 17). The site could be enhanced by removal of the rock and recreating a wider beach and backshore area. The site was filled to a higher elevation, likely during development of the marina, as shell fragments were observed in the eroding bank. An upper beach and backshore area would be created between retained (adjacent) bulkheads, resembling the upper part of a pocket beach. A small portion of the removed rock would likely be required for construction of return walls (running landward at the ends of adjacent bulkheads, designed to minimize end effects). These return walls would generally run landward along the property lines. The upper beach should also be nourished to aid in the reformation of lost forage fish spawning habitat area covered by riprap. Additional restoration recommendations for this site include enhancing the marine riparian area.

Figure 16. Air photo of Sunset Beach site, note toppled and infringing riprap at west end of site (Pictometry International Corp 2004)

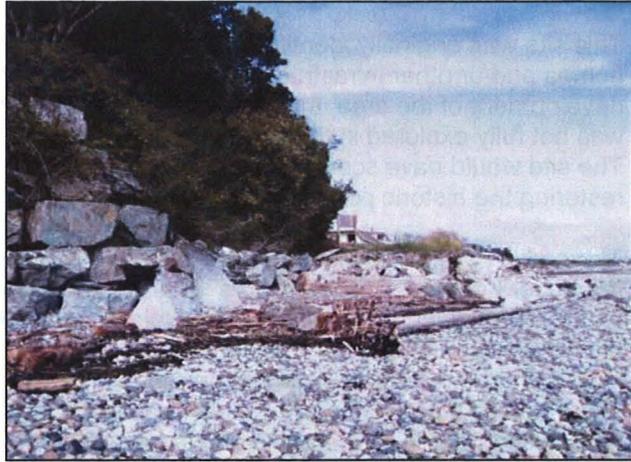
Figure 17. Infringing riprap at Sunset Beach (CGS field photo).

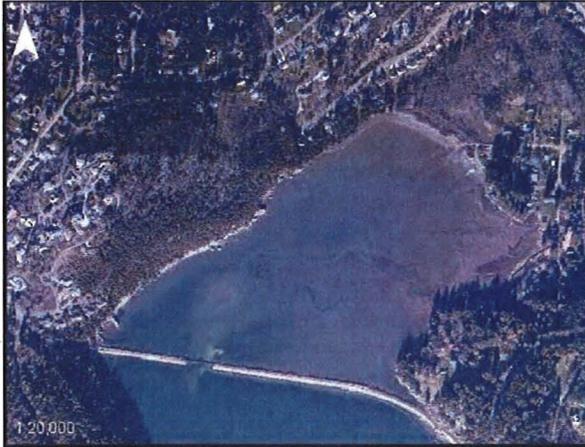
The causeway currently covers 153,040 sq ft of subtidal and intertidal area. The beach was historically composed of coarser material and apparently eelgrass beds were found throughout the inner shore of the Bay (Pers. Comm. T. Wahl 2007). Currently inner Chuckanut Bay beaches are comprised of relatively fine sediment (sands and silt) and patches of eelgrass are only found in the waterward end of the Bay. It is likely that if sedimentation rates continue at the current accelerated rate the Bay will experience further habitat degradation in the form of water quality issues, exceeded temperature thresholds for salmonids, and the progressive loss of intertidal area. It is likely that the tidal prism has already been substantially reduced in volume due to the accelerated sedimentation occurring within these shores. This process will likely be slowed by sea level rise, however, the native substrate of the beaches and the natural tidal hydrodynamics will not be recovered without restoration actions.

Figure 19. Aerial view of Chuckanut Bay causeway (Pictometry International Corp 2004).

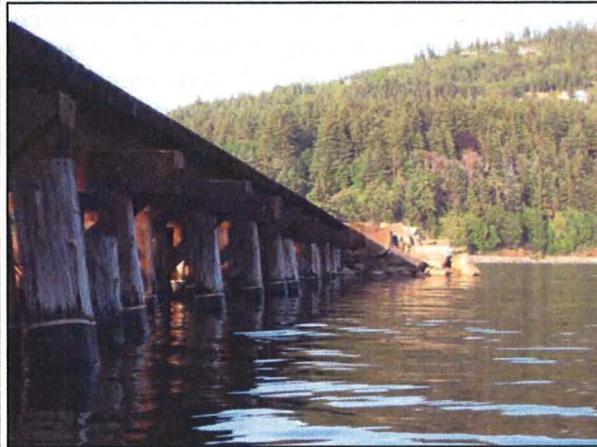
The causeway created additional shoreline along the revetment and the open shaded area beneath the causeway opening is the only access to the bay (Figure 20). The shading and additional riprap shoreline, provides an abrupt transition from shallow to deep water, likely increasing migrating juvenile salmonids' vulnerability to predation. The causeway opening was also constructed of heavily creosoted pilings, which likely adversely impacts water quality.

Figure 20. Chuckanut Bay causeway opening, creosote pilings (CGS field photo).

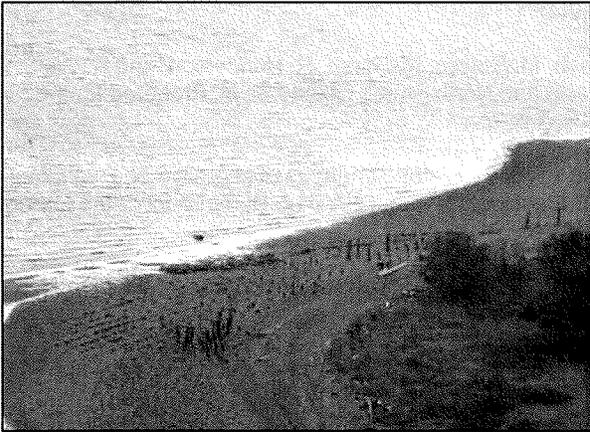
Removal of these relict items would restore intertidal habitat structure and ameliorate adverse impacts to water quality caused from the further decay and erosion of the slag and car parts. The field of over 100 relict piles would recover lost intertidal substrate, and enhance alongshore sediment transport that appears diminished due to wave attenuation caused by the piles and slag deposit. Juvenile salmonid migration pathways would likely also be enhanced as a result of the restoration. The cumulative targeted response of these actions was awarded 18 out of 45 points for these reasons.

Figure 21. Lily Point piling field (CGS field photo).

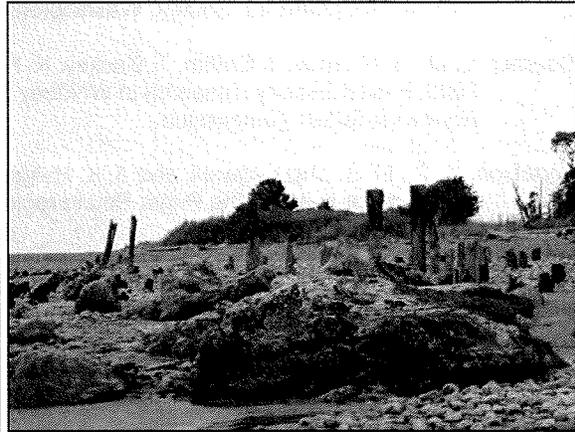
Figure 22. Slag deposits in lower beachface left from old cannery (CGS field photo).
