**Tree Retention Plan  
'Cityview'  
4413 Consolidation Ave., Bellingham WA  
Township 38N, Range 3E, Section 32  
Bellingham, WA 98225**

**Prepared by:  
Tree Guys Incorporated  
Patrick J. Sullivan  
International Society of Arboriculture  
Certified Arborist # PN-7123A  
Certified Tree Risk Assessor  
Bellingham, WA  
(360)920-6285  
February 15, 2020**

**February 15, 2020**

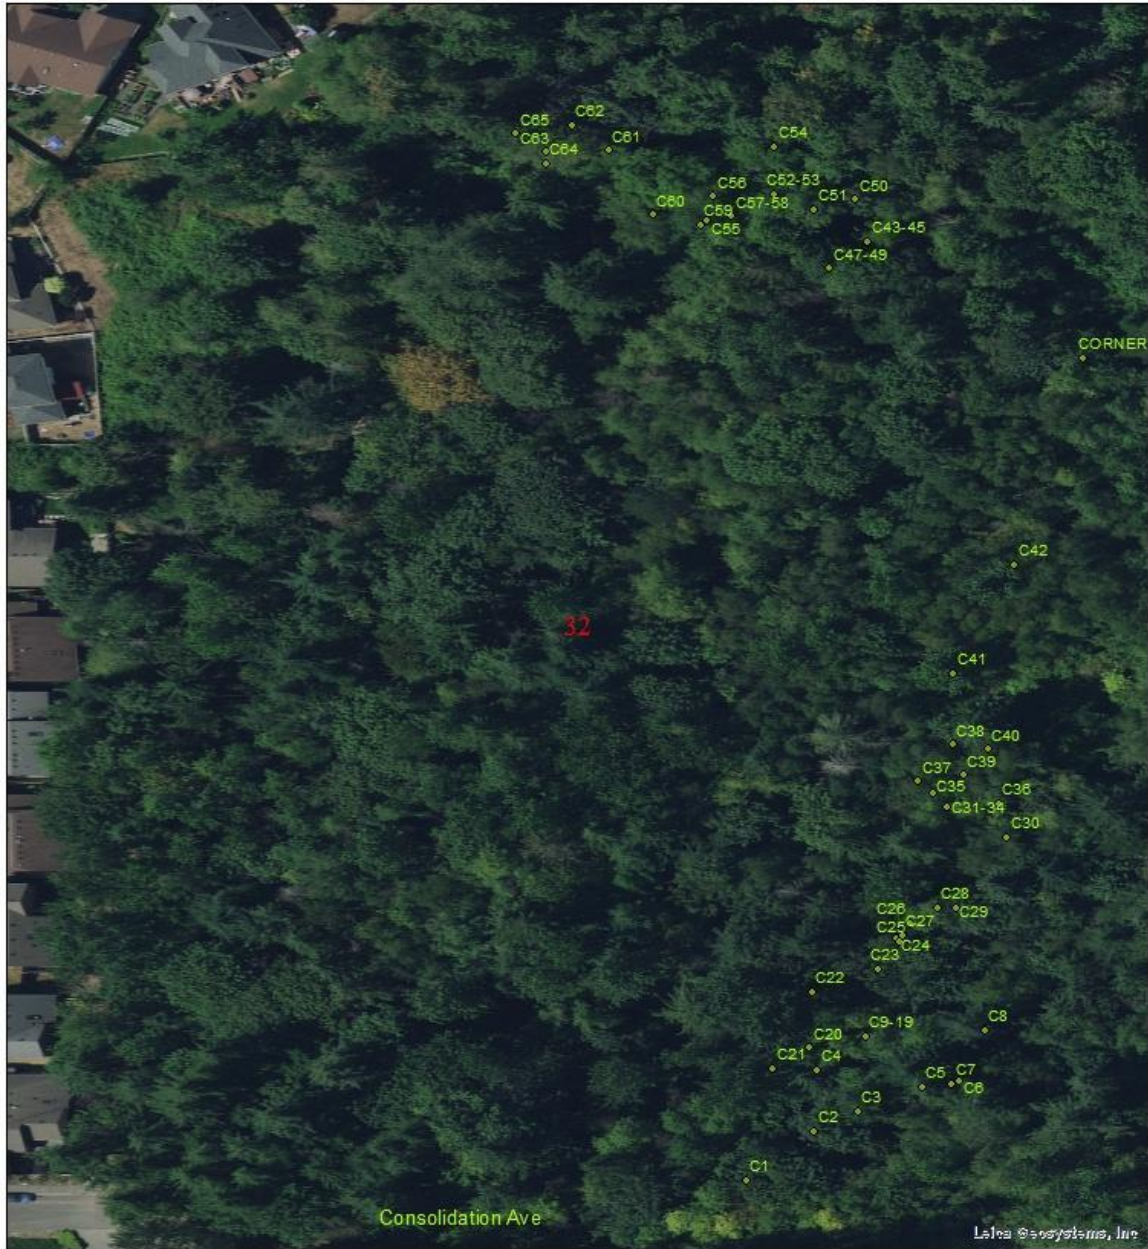
Appendix 1  
Consolidation Ave Tree Risk Map  
1:1200  
February 2020

- Location of buildings and infrastructure, designed to minimize clearing and ensure no conflicts with the critical root zones of the retained native forest.
- Location of survey flags and silt fencing to clearly identify the grading zone boundary, as well as protect the critical root zones of the undisturbed trees.
- Location and species of replacement trees.
- Clear outline/shading to identify both the grading/construction zone (51.4%) and the retained native forest (48.6%).
- Location of trees recommended for removal within the retained native forest.

Survey flags have been placed on site (see The Map, outline of grading/construction zone) running north/south for approximately 590', then shifting west, running east/west for approximately 400'. This inner portion of this flagged area represents the grading boundary of the project. Trees located within 100' of the grade line or located one and one half the distance of the trees' heights have been carefully assessed. Sixty five trees with DBH greater than 6" were assessed within this zone as 'possible', 'probable' or 'imminent' risk for failure (see Table 1). Therefore their removal and replacement is recommended.

In the area between tree C42 Black Cottonwood and C43 red alder, there is a dog haired stand of hardwoods struggling to become established (within the Tree Retention Area, see The Map). This area is at the foot of the steepest slopes on the property. Poor tree growth is most likely from rocky, low site production soils. As a result, there are many hardwood individuals lacking significant tree heights and well under 6 inches in diameter. If left to grow, these trees will carry similar tree characteristics as the mature hardwood rated as high in risk. I recommend removing all short trees within 30-40 feet of the surveyed grade line and replanting native understory species in the same location that can survive in poor soils.

Finally, 23 trees (C43-65) within Wetland B and/or it's buffer are listed as 'Possible, Probable, or Imminent' for failure. Per Table 1, I recommend removal of these trees and a replacement ratio of 2:1 per Page 3 of this report. Replacement trees should be planted outside of the wetland/buffer.
