LITTLE SQUALICUM CREEK WETLANDS MITIGATION PLAN

**LITTLE SQUALICUM CREEK
OFF-SITE WETLANDS MITIGATION PLAN**

January 24, 1992

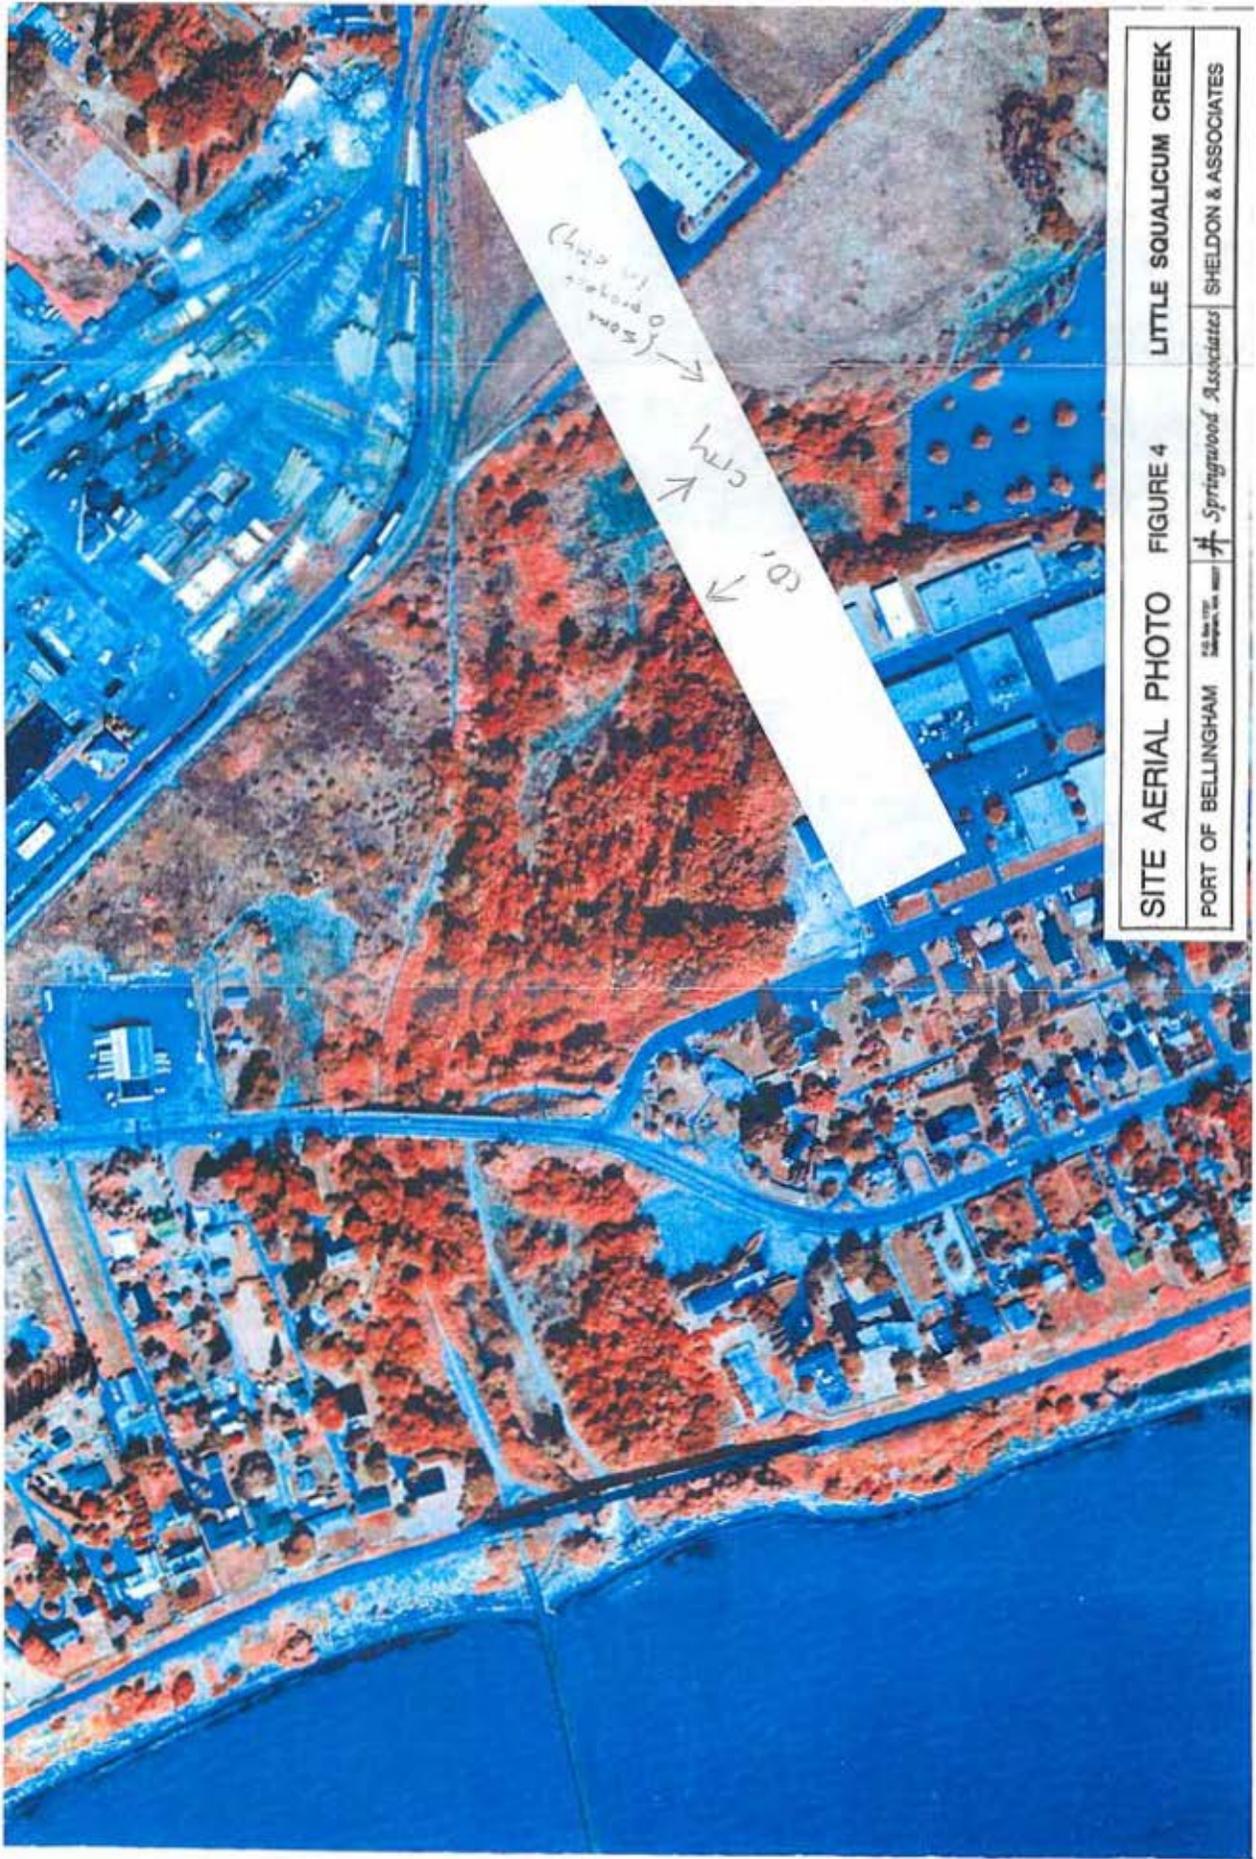
FIGURE 4

SITE AERIAL PHOTO

The site encompasses the remaining lower section of Little Squalicum Creek and extends westward to Bellingham Bay. It is bounded on the south side by residential areas and the Bellingham Technical College (BTC), on the west by Bellingham Bay, on the north by an old railroad line. See Figure 4: Site Aerial Photo.

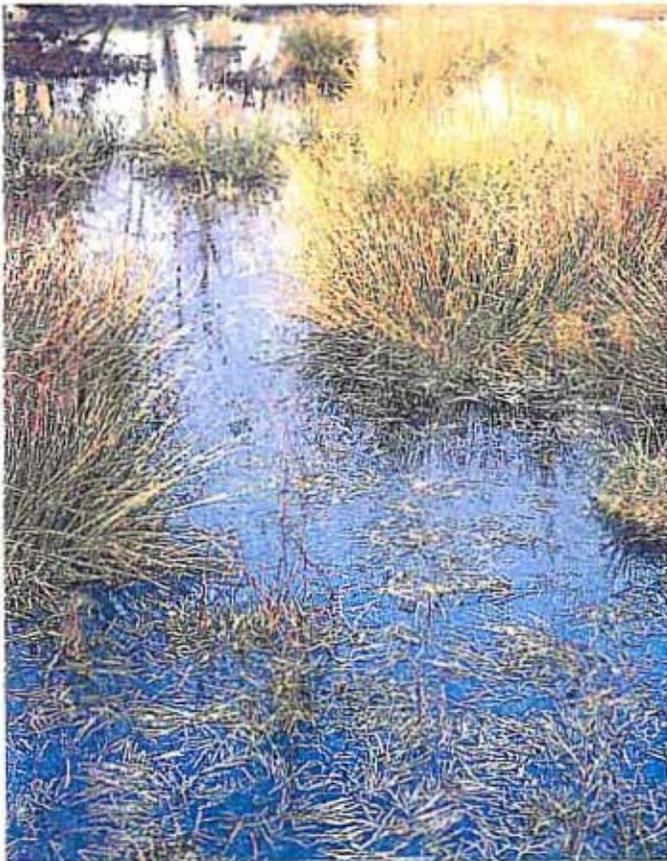
A. Shallow emergent wetland

Reference plant communities were selected from 8 sites around Whatcom County to provide information about local plant associations and wetland conditions that will be useful in designing new wetlands systems. The three plant communities types proposed in this mitigation (wet meadow, emergent, scrub-shrub) will be based on these local reference communities. See Figure 9: Reference Community Photos.

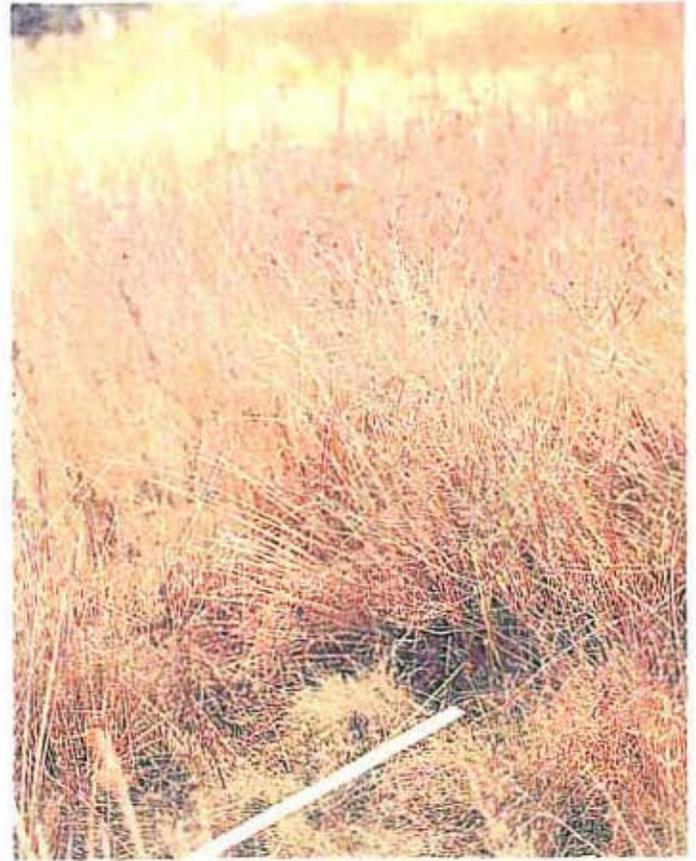
B. Wet meadow with rose

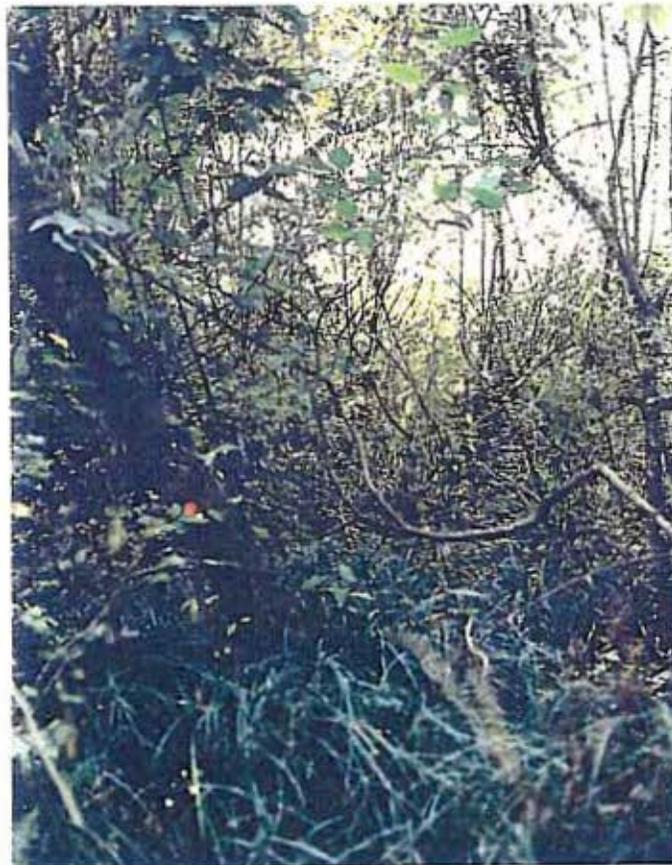
C. Forested wetland with scrub-shrub/emergent

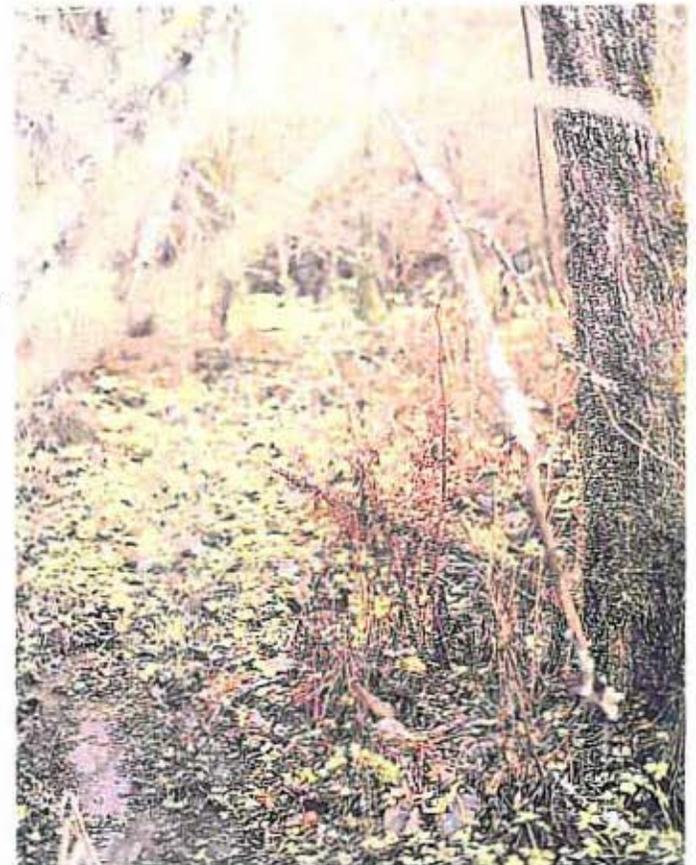
D. Scrub-shrub wetland with emergent understory

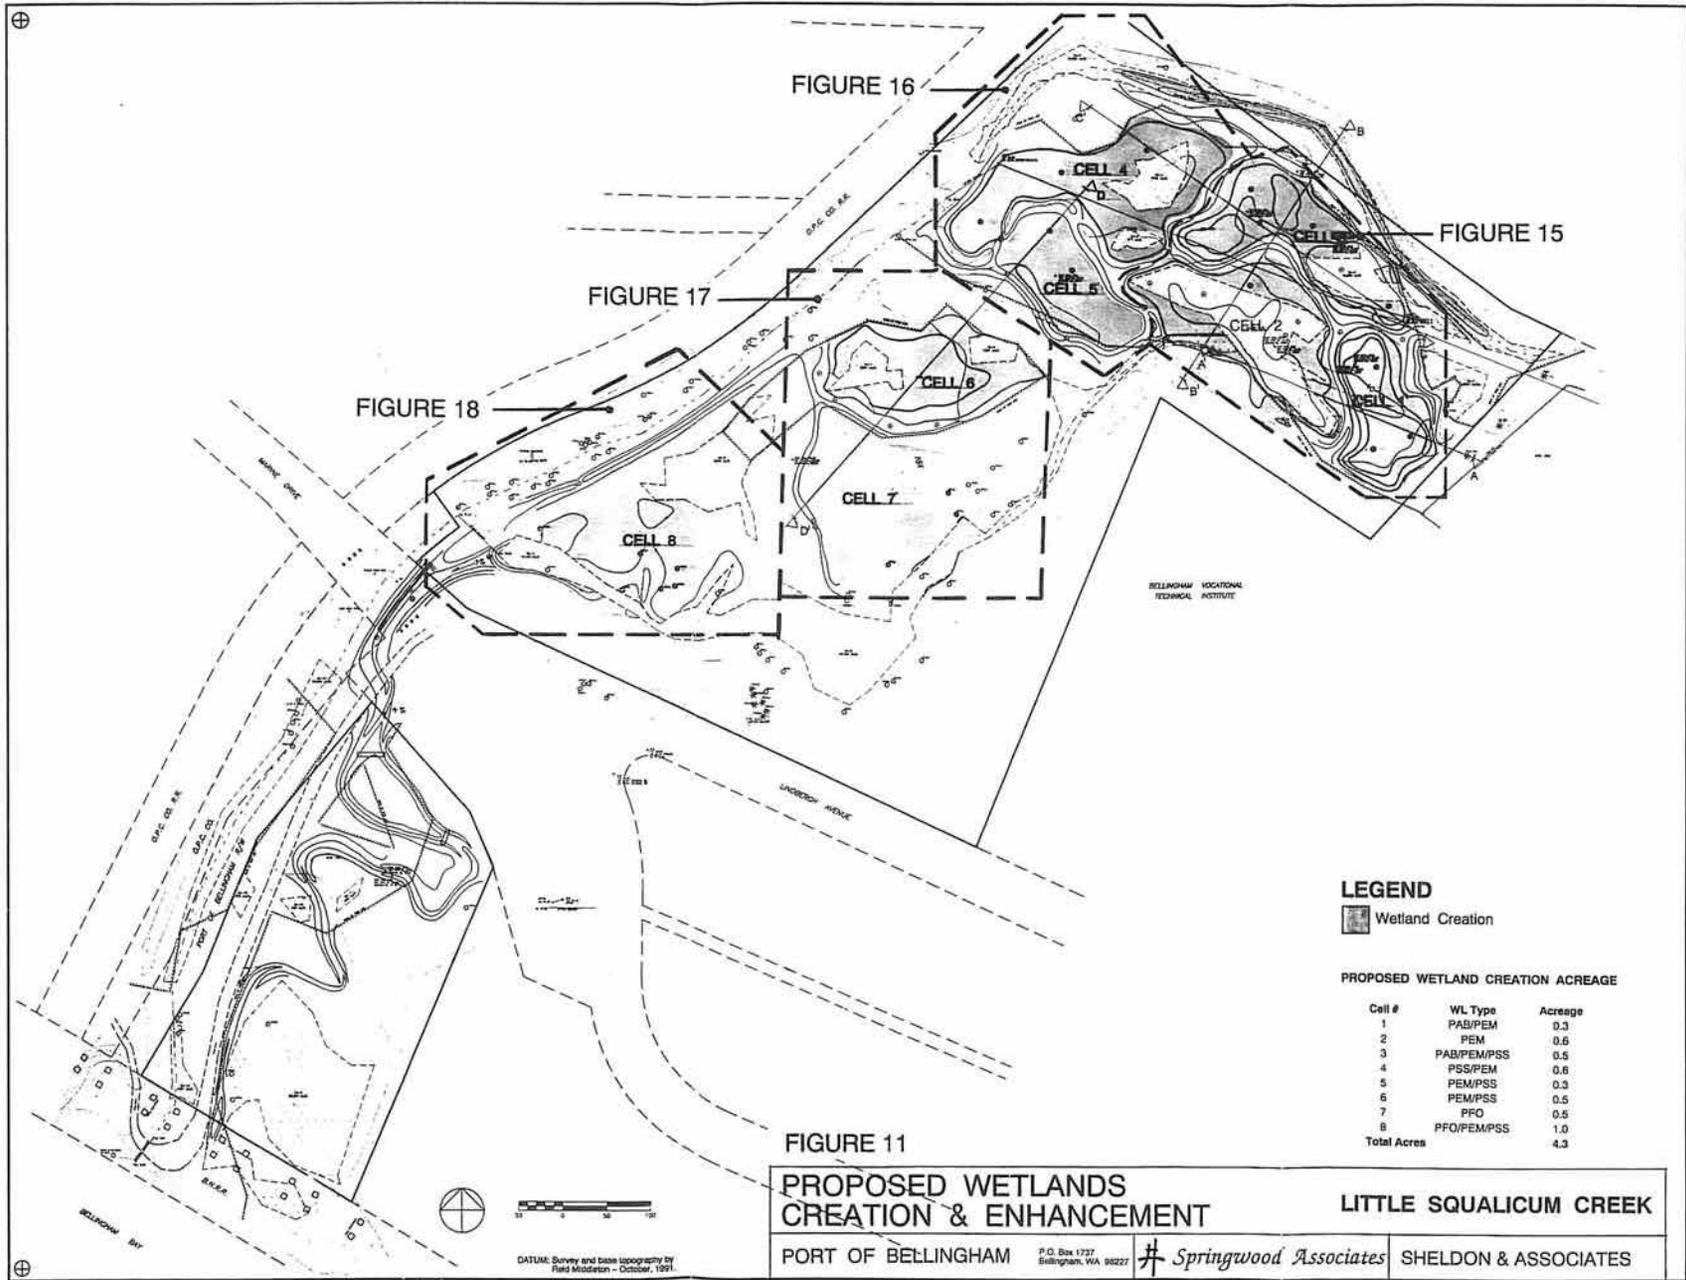
FIGURE 11

**PROPOSED WETLANDS
CREATION & ENHANCEMENT**

These wetlands generally have low plant diversity and little structure. The wetlands creation proposed in this plan intends to augment and in some instances replace the low functions and values of the existing wetlands. The majority of the wetland creation and enhancement will occur in the area east of the Marine Drive overpass. See Figure 11: Proposed Wetlands.

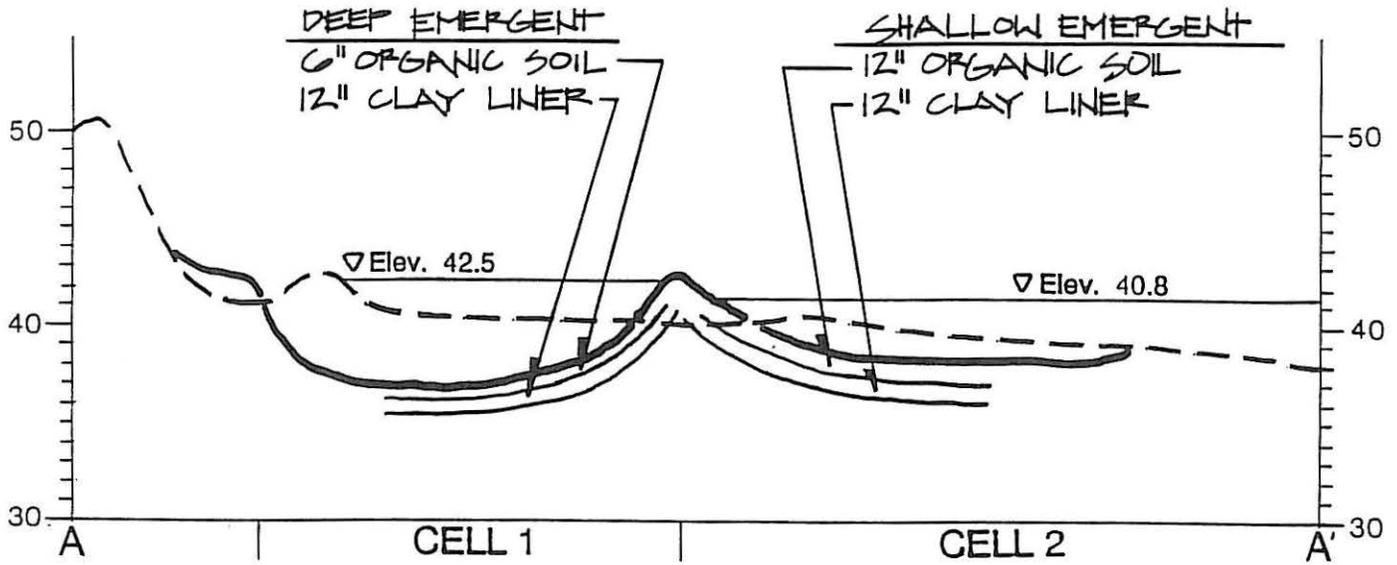
SECTION A - A'

Existing Grade

All areas to be planted will be over-excavated and backfilled with approximately two feet of a sandy clay loam soil with an infiltration of not more than 0.16 inches per hour, or a 12 inch lift of clay will be put down to hold water and slow the rate of infiltration. If a clay liner is used, an organic soil amendment will be incorporated into the native soil and placed over the clay liner. Imported topsoil will then be placed over the amended native soils to provide a suitable medium for plant growth and establishment. Wetlands soil salvaged from the proposed project site and other donor sites can be used to provide a seed bank of wetland species. See Figures 13 & 14: Grading Sections.

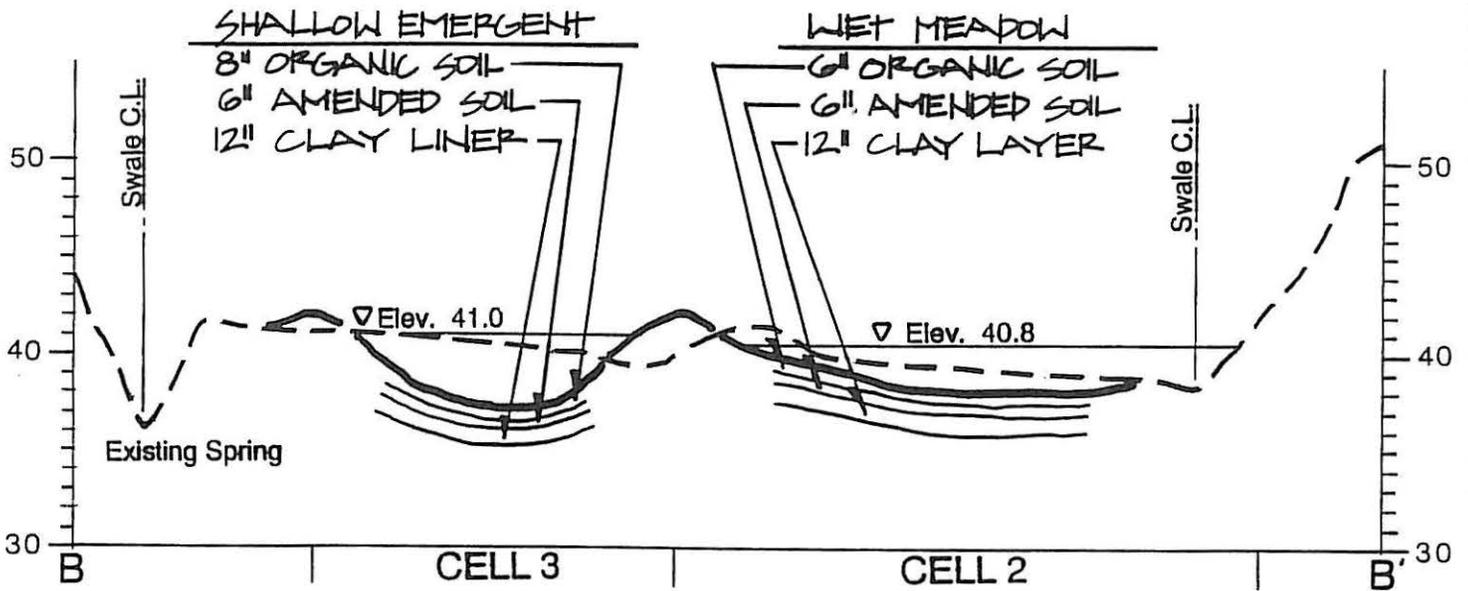
SECTION B - B'

Existing Grade

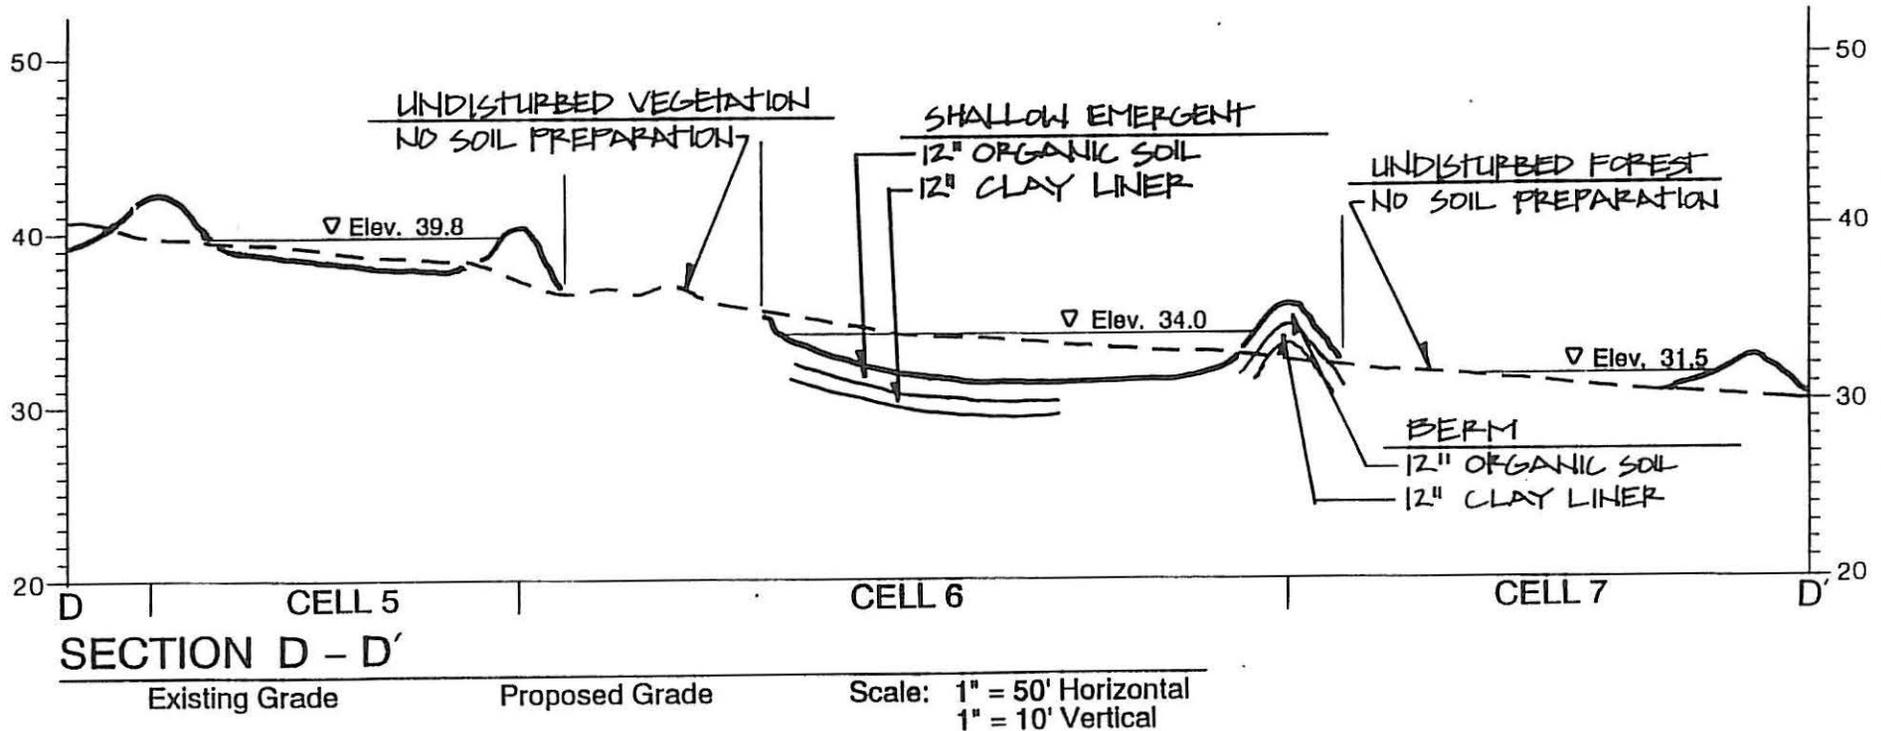
FIGURE 14

GRADING SECTIONS
Port of Bellingham

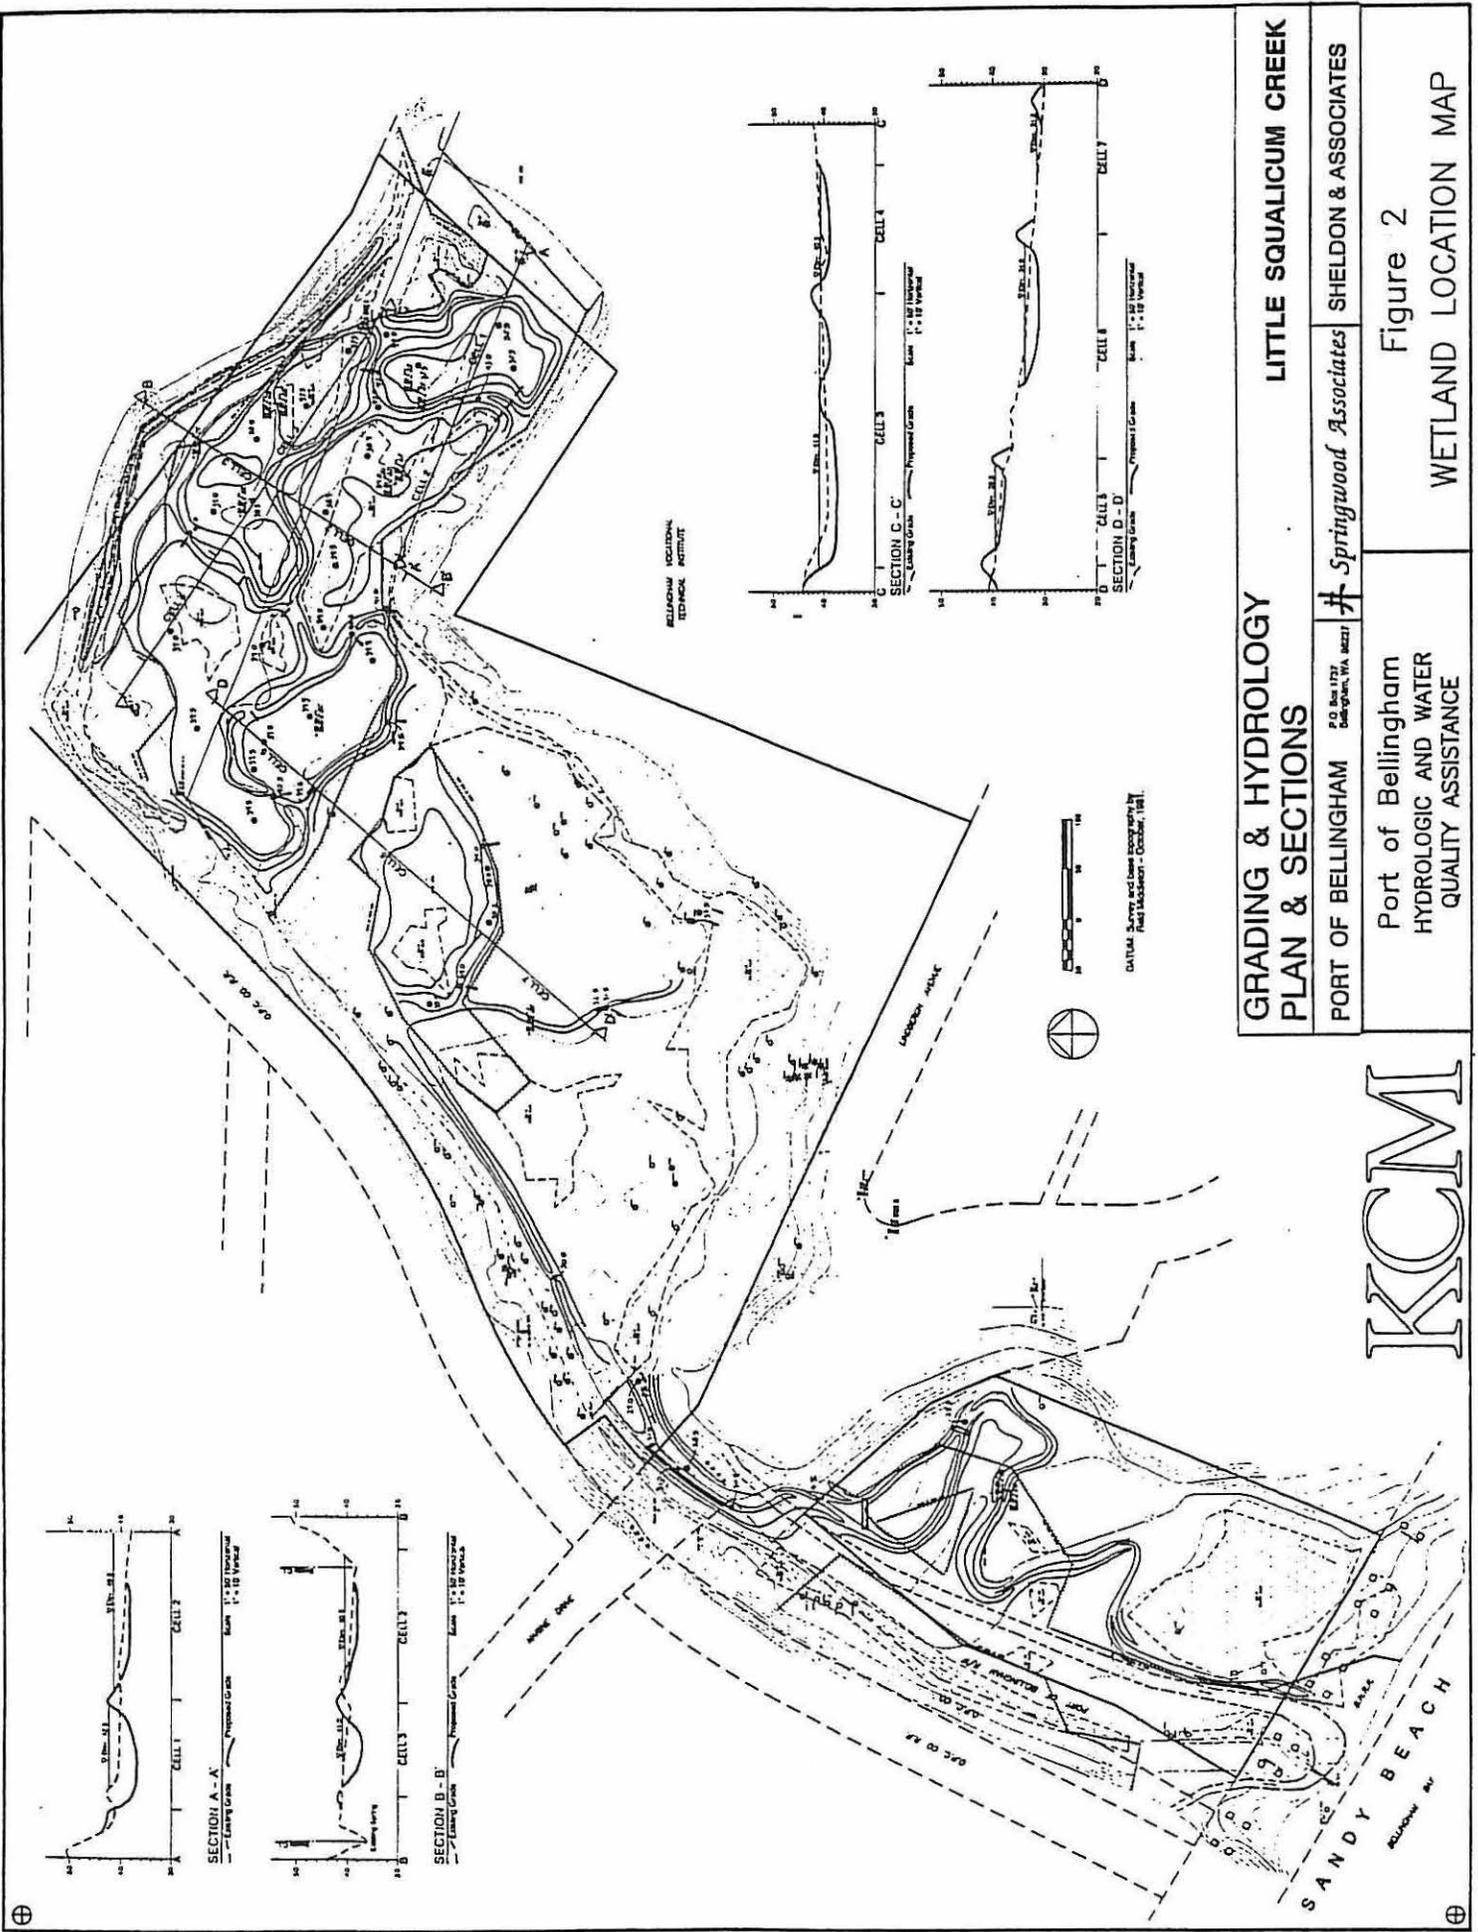
**GRADING & HYDROLOGY
PLAN & SECTIONS**
