## Item 4.2 of “Adapting Woodstock” Charrette “Site Planning Topics & Reference Items”

### The BNSF Railway Causeway & Its Potential Modification

Text and recent photos by Tim Wahl, July 2008

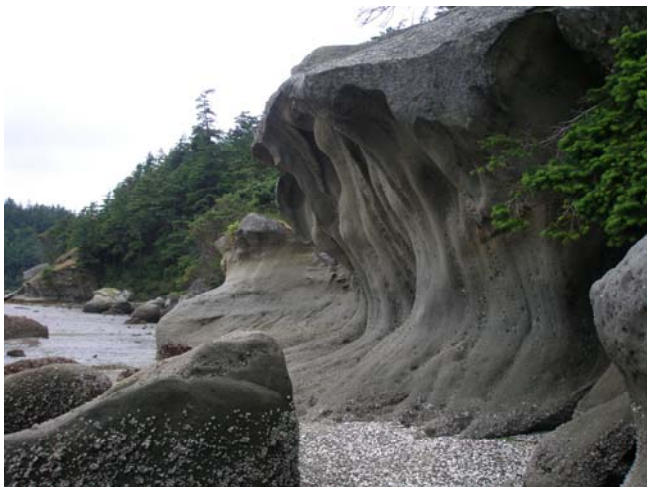
The Item 4.3 poster presents several historic records reflecting NE Chucakanut Bay's original depth, beach and substrate composition. Before the railroad, the bay's cul-de-sac opened directly into the regions most powerful storms which blow from the SW and generate waves over a fetch up to 9 miles in length extending across Samish and Bellingham Bays. For thousands of years the shore opposite Woodstock to the N experienced high energy wave action, which is readily evident in the accompanying pictures.

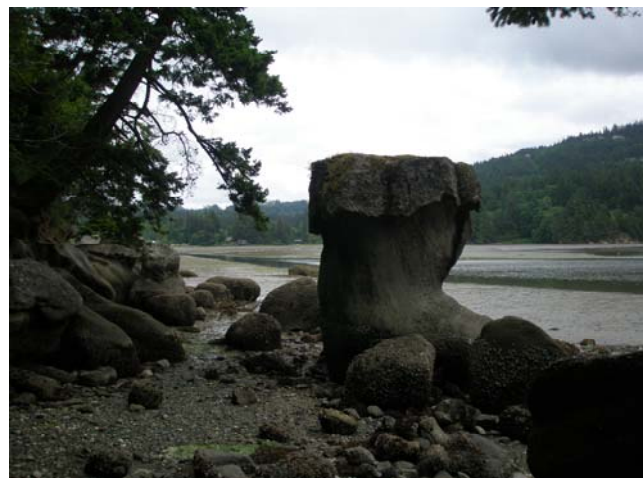
The loss of wave energy reflected from the N Bay shore, whether in the form of a clockwise an eddy or as direct counter waves, or both, is apparently the main reason the midden bluff at the Lee boathouse is eroding. Historic photographs show a more gradually sloping, vegetated bluff at the boathouse and eyewitnesses over the past 40-50 years report a significant increase in undercutting and sloughing of the culturally deposited bank material. Perhaps a shoaling of the adjacent basin due to sediment accumulation has also changed the way wave energy affects the shell midden deposit.
