Bloedel Donovan Park Master Plan Amendment

Process and Summary

July 2, 2012

Prepared By:
CITY OF BELLINGHAM
PARKS AND RECREATION DEPARTMENT

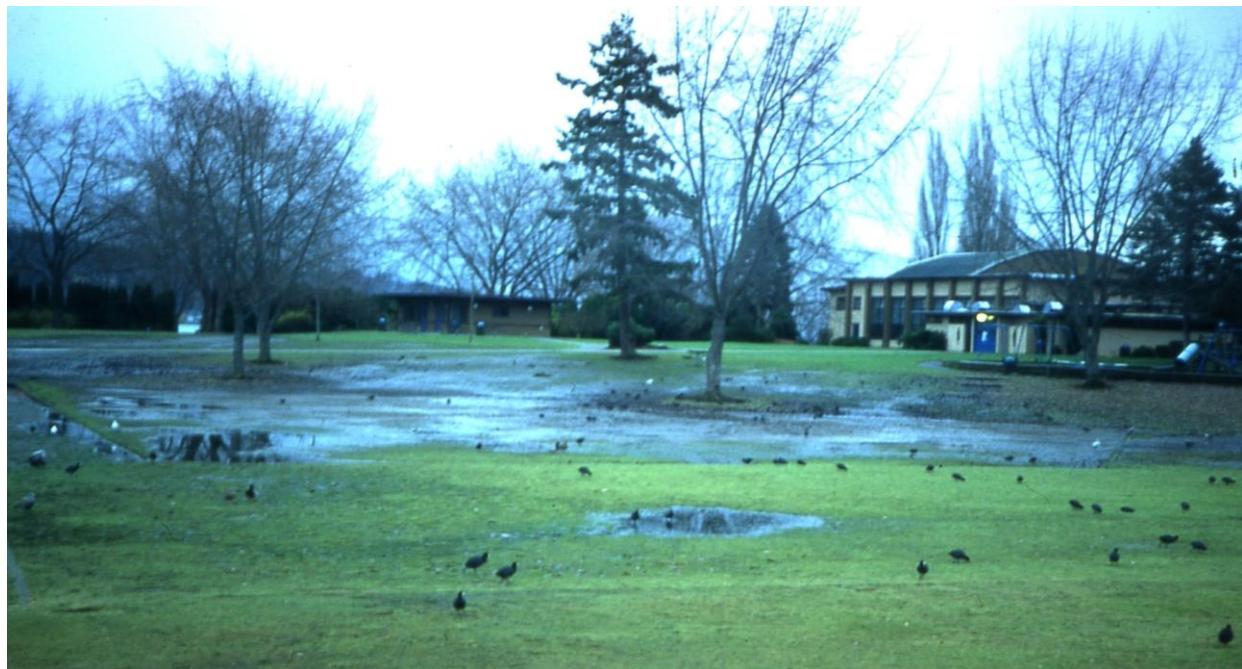
Turf damage due to migratory waterfowl

Migratory waterfowl: Migratory waterfowl, primarily Coots and Canadian Geese, have been a maintenance challenge at the park for years. Photos from the 1980's reveal turf damage directly attributed to a variety of migratory waterfowl. In addition to the turf damage, waterfowl excrement resulted in a less than satisfactory recreation experience for swimmers and other park users. In 1999 the beach was designated as an off-leash dog area in an effort to haze the waterfowl. Currently, off-leash dogs are allowed in the park during daylight hours from October 1 to April 30, as well as from 6 a.m. to 10 a.m. from May 1 - September 30. In recent years, use has been restricted based on monitoring of turf damage.

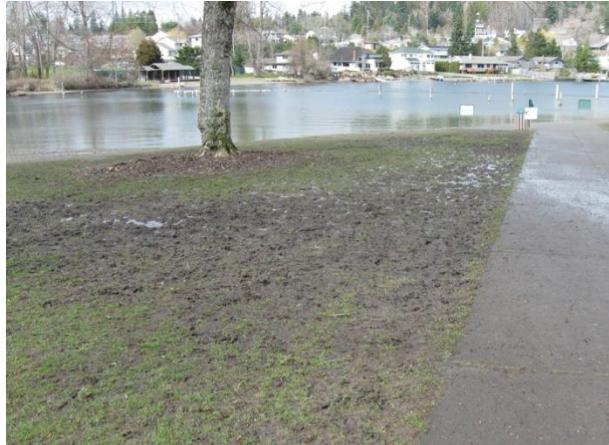
Turf damage due to off leash dogs – winter 2010

Off Leash Dogs: As mentioned, the practice of allowing off-leash dogs along the beach has proven to be an effective measure in hazing migratory waterfowl from the park. This opportunity has been very popular for dog owners. Unfortunately, during the winter months, the increased number of dogs is taking a toll on the turf and soil sediments are draining into the Lake. The Public Works Storm Water Division and the Department of Ecology, identified sediment drainage into the lake in winter 2010 and the Parks & Recreation Department immediately erected temporary fencing to close part of the area protecting the turf from dog damage and the resultant sedimentation. In the past two years, the area north of the parking lot has been temporarily closed to off leash dog use during winter months prevent bare soil areas and resulting sedimentation migrating into the lake.

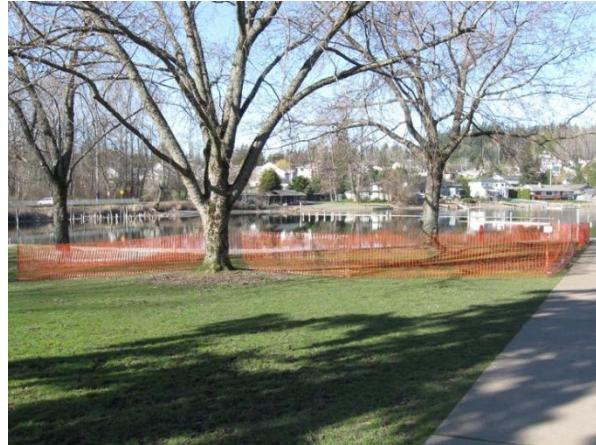
Protective fencing – erected winter 2010

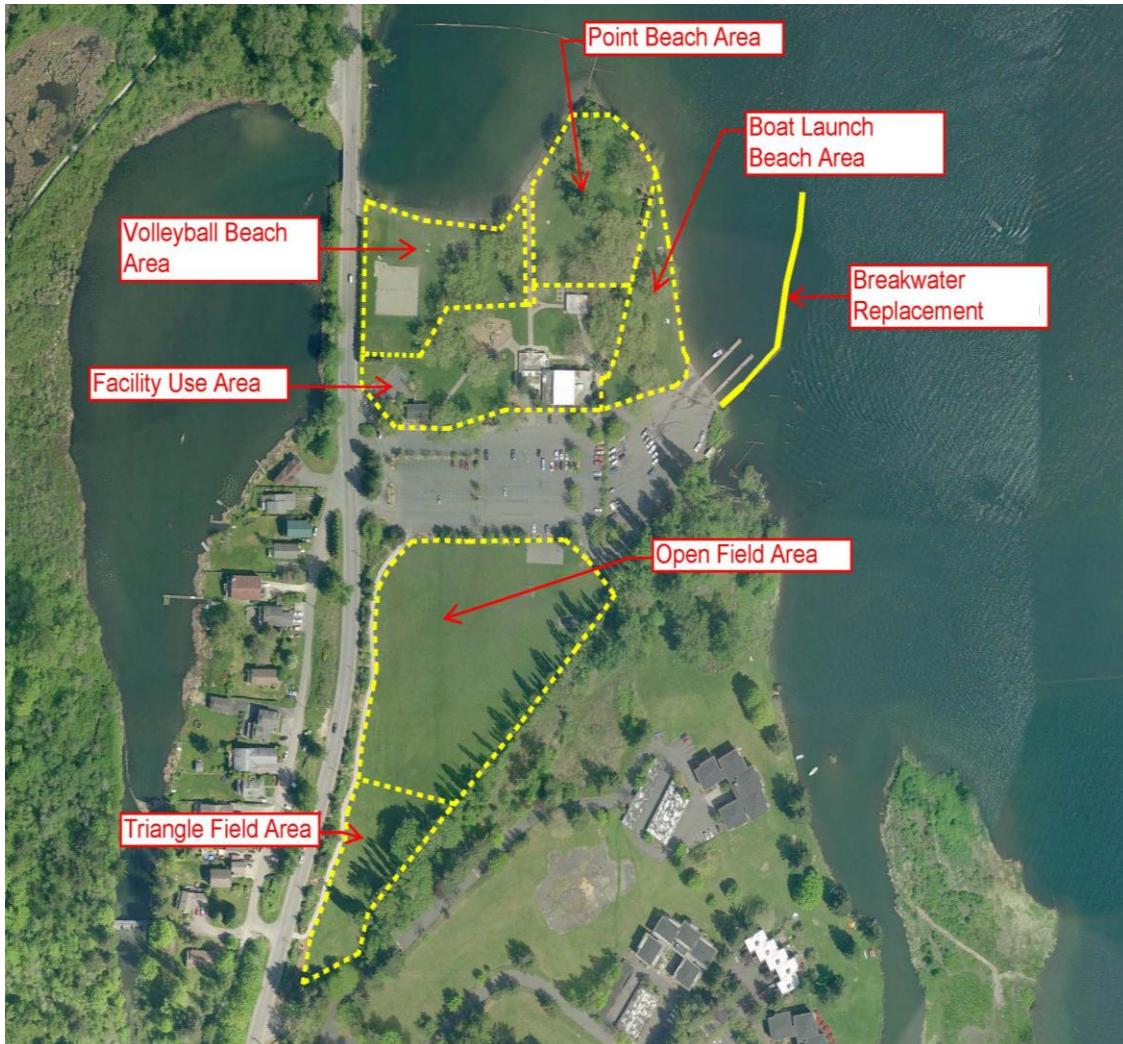
Breakwater Replacement Location

- 1. Replace breakwater system:** During the summer of 2010, wood pilings and log booms installed in 1983 to help protect the east shore of the park and the boat launch area were removed and replaced. Less than half of the original wood pilings remained above the waterline and the original three log boom system (three logs bundled together) were reduced to single logs with buoyed lines. With the loss of the booms, the erosion along the easterly side of the park has increased and the existing bulkhead is failing. In addition, it has become increasingly difficult to launch and retrieve boats in the launch facility.

The wood pilings and booms have been removed and steel pilings have been installed. The log booms are being replaced with plastic cylinder wave attenuators approved by the Army Corps of Engineers.

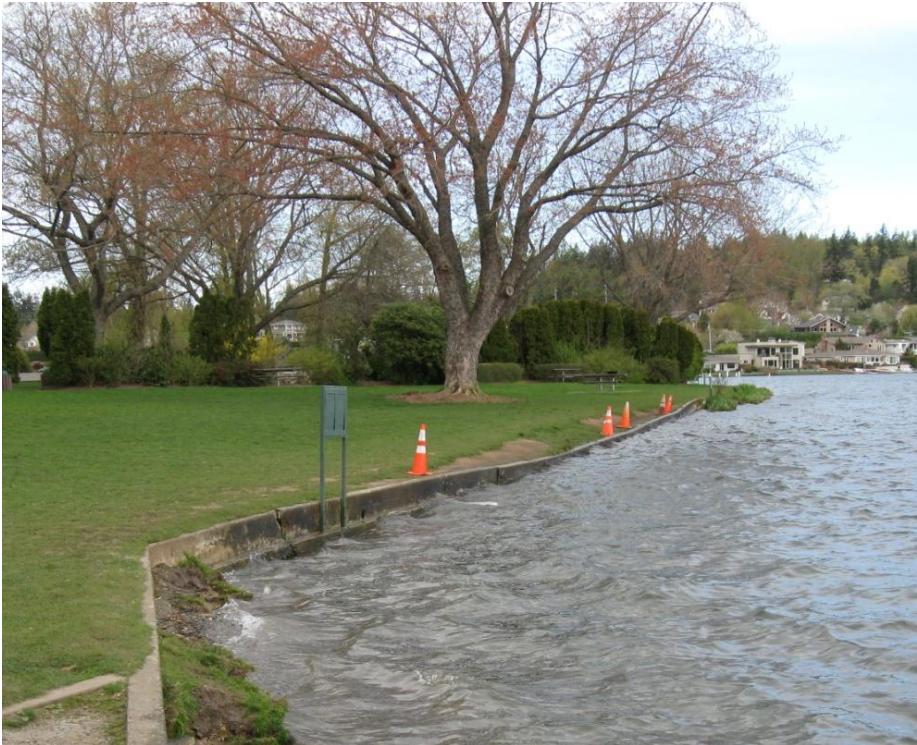
Failing bulkhead at Bloedel Donovan Park

The existing concrete bulkhead along the east shoreline is failing. Soil is eroding from behind and below the wall into the lake. This results in safety concerns where the soil behind the wall is settling. This also results in water quality issues as topsoil is deposited into the lake.

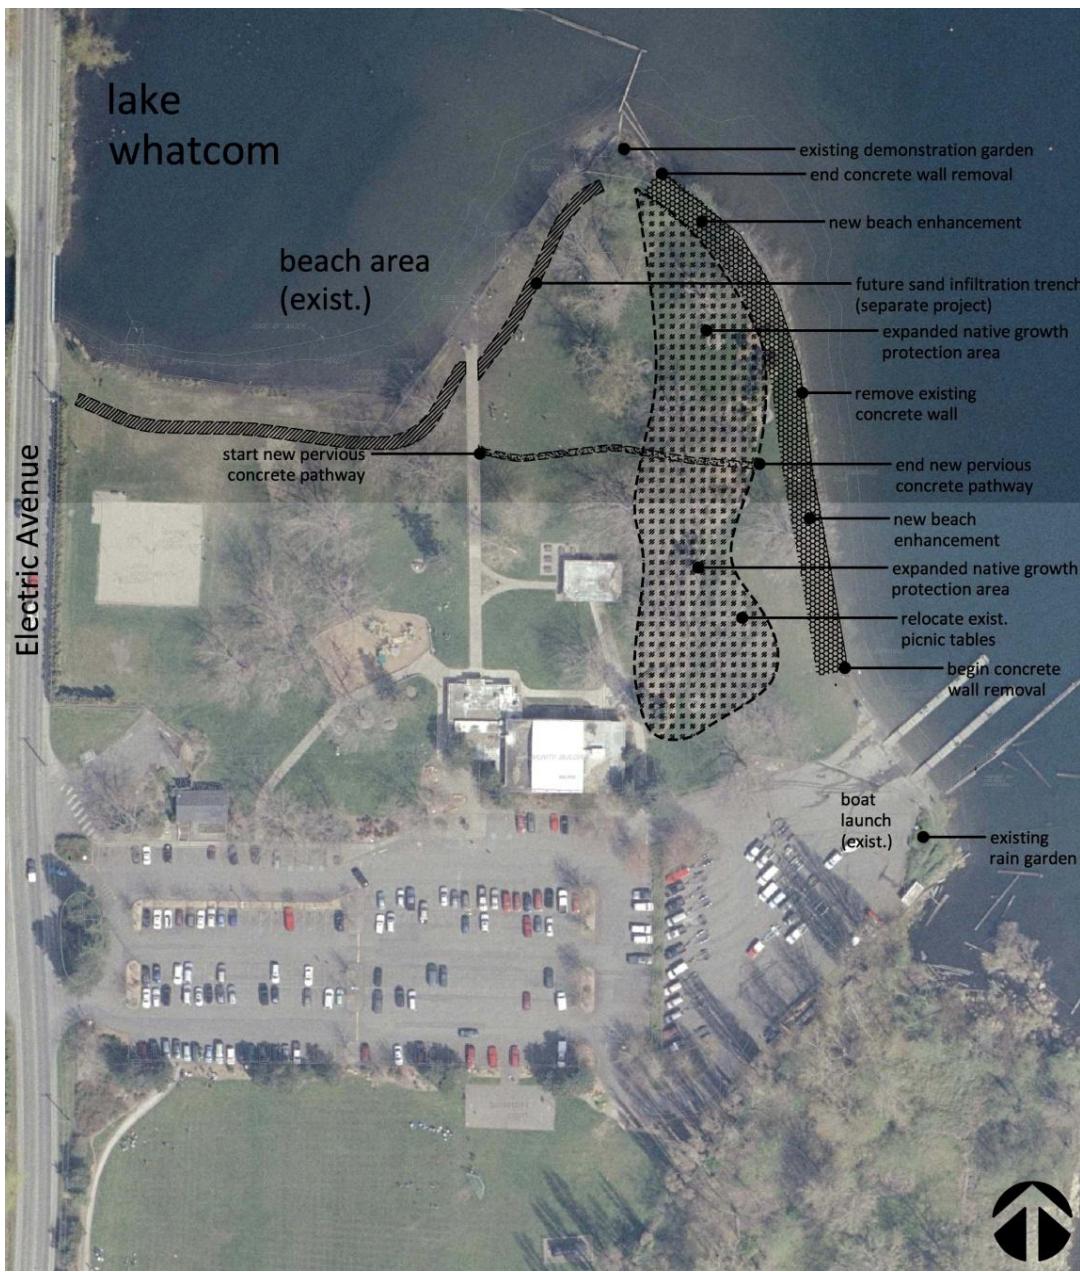
Proposed Shoreline Restoration

2. Bloedel Donovan Shoreline Restoration: Parks and Recreation Department Staff, in coordination with Public Works Storm Water Division and the Planning Department's Shorelines Planner, have investigated potential lake friendly options to remove the failing bulkhead and improve storm water run-off. The proposed project implements LID retrofits to mitigate for or eliminate sources of nutrient and bacteria loading in storm-water runoff from the park into Lake Whatcom. The project design utilizes reforestation and infiltration as Best Management Practices to mimic native forest conditions and sand media filtration to provide enhanced treatment.

The project is estimated to cost up to \$500,000. A grant application is in process with Public Works Water funds providing a match. Some work may be done in-house with City crews.

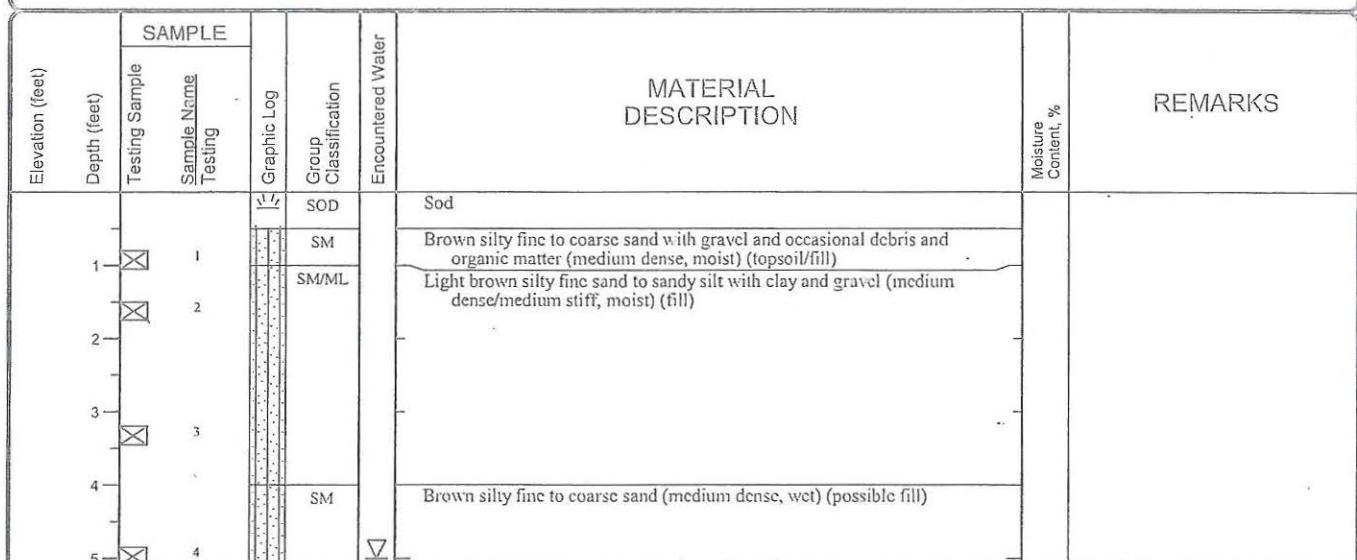
Slow groundwater seepage observed at 5 feet

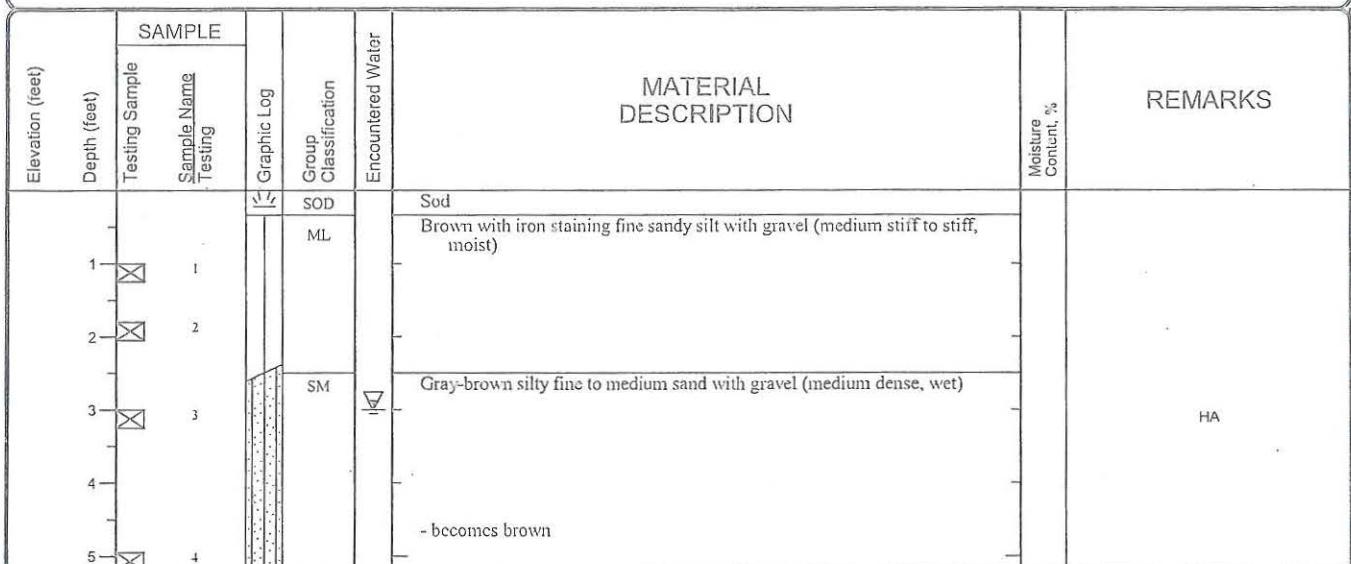
Slow groundwater seepage observed at 3 feet

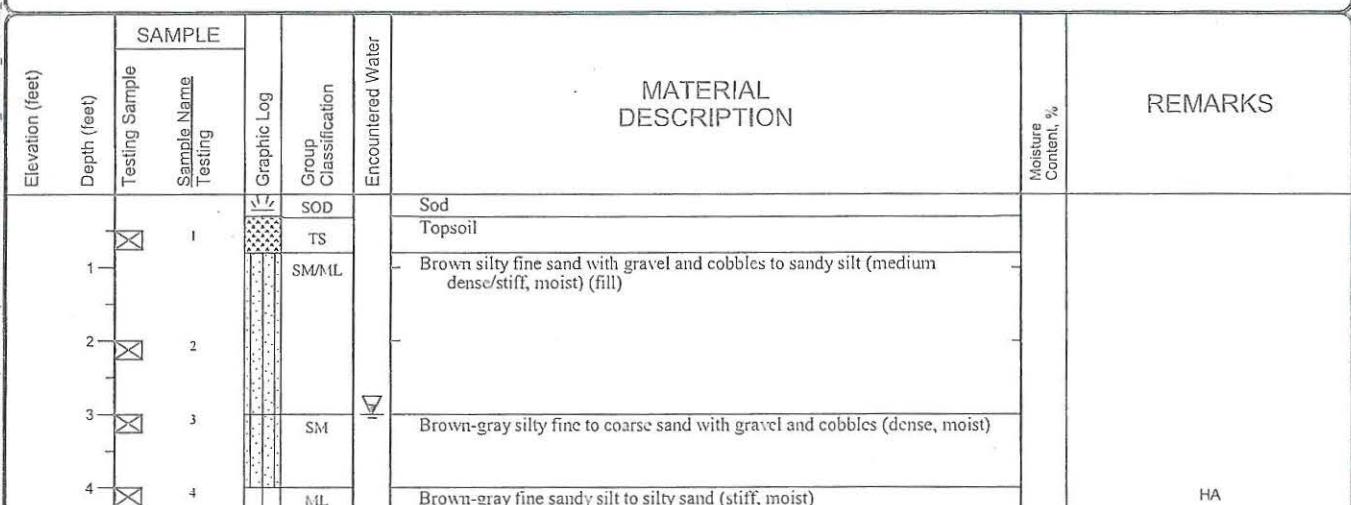
Refusal on large cobble
 Slow groundwater seepage observed at 3 feet

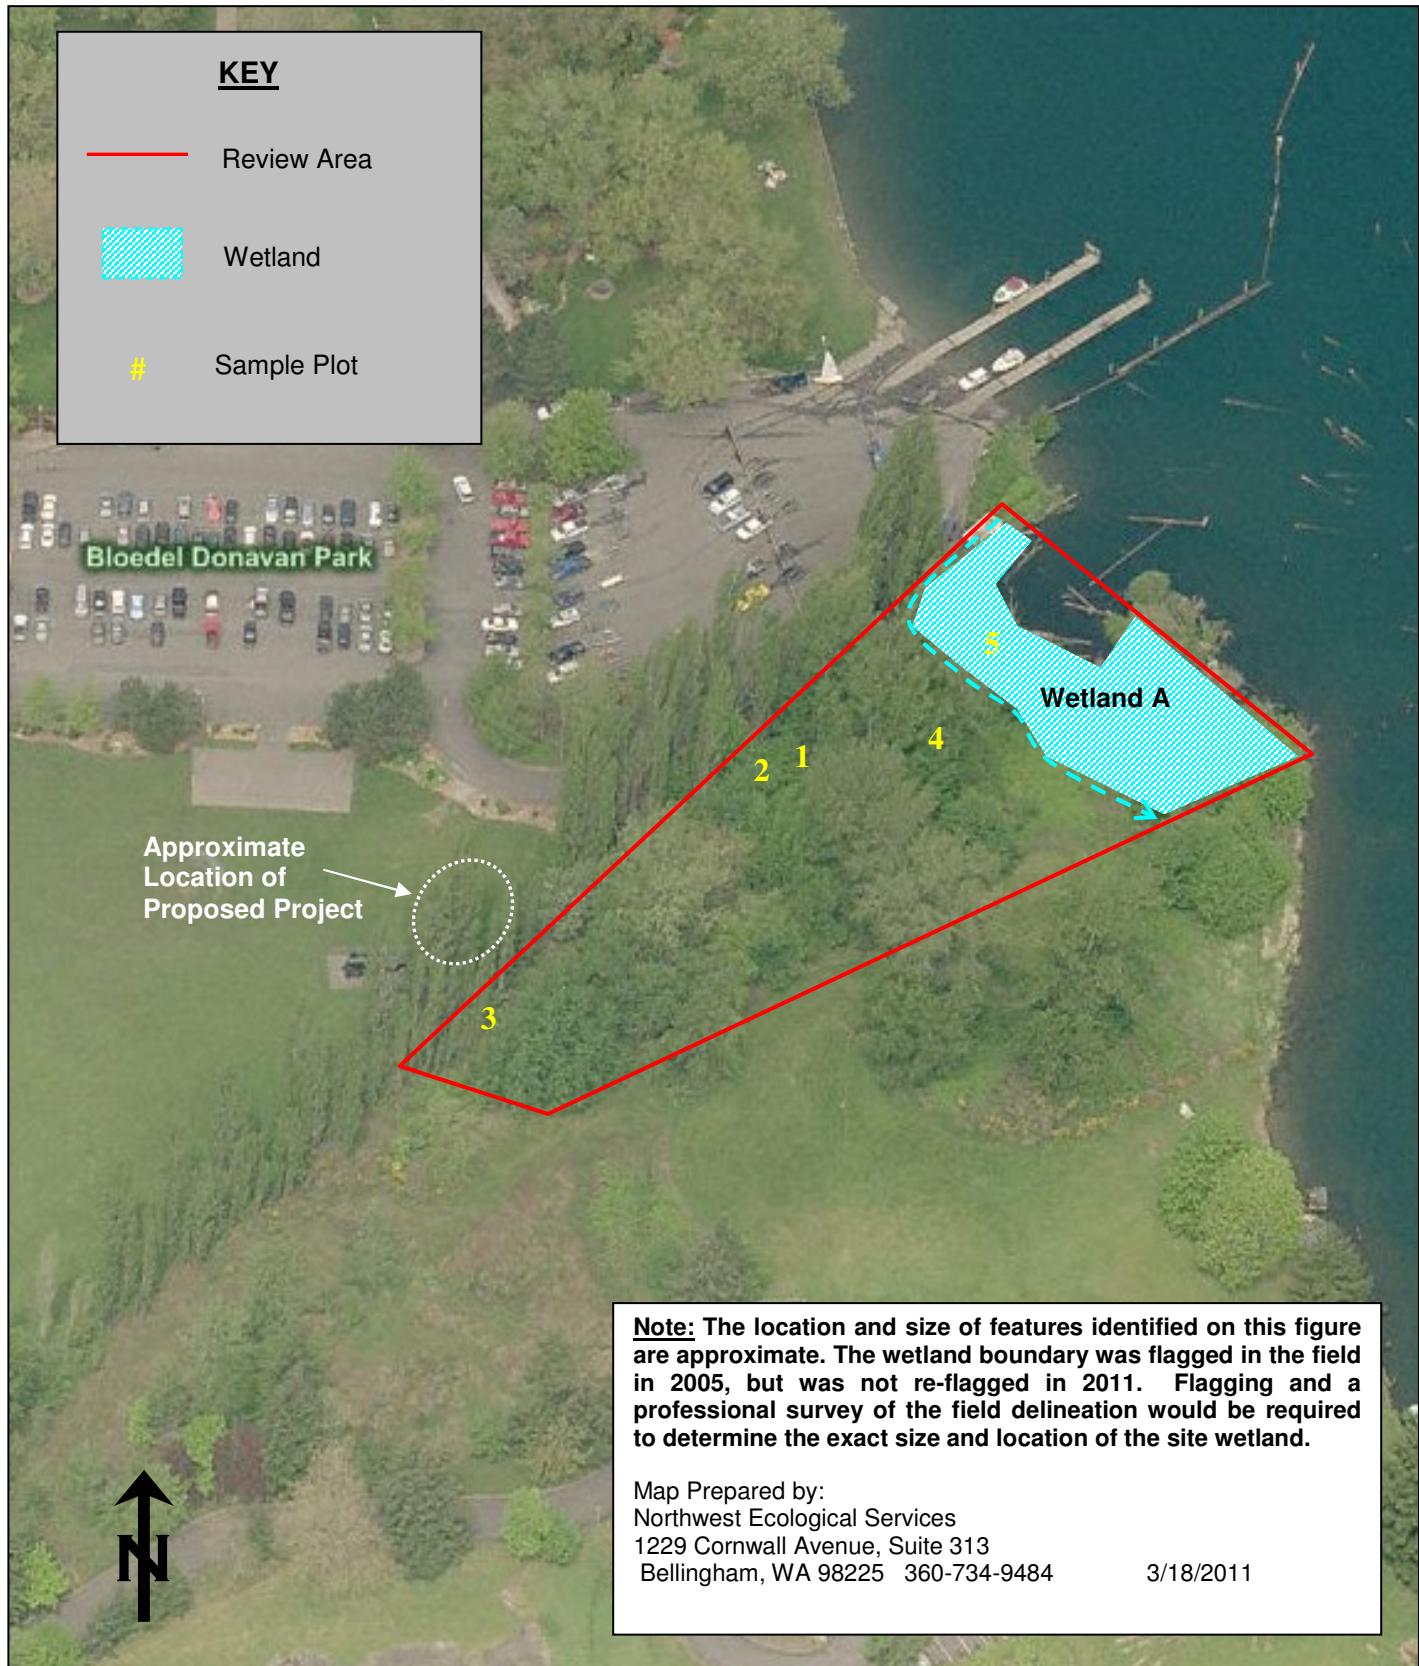
ECOLOGICAL 	Wetland Sketch Map (Bing Maps, 2011) Bloedel Donovan Park Public Rowing Facility	Figure 2. March 2011
-----------------------	--	------------------------------------
