# City of Bellingham

## Watershed Master Plan September, 1995

**CITY OF BELLINGHAM  
WATERSHED MASTER PLAN**

## **EXECUTIVE SUMMARY**

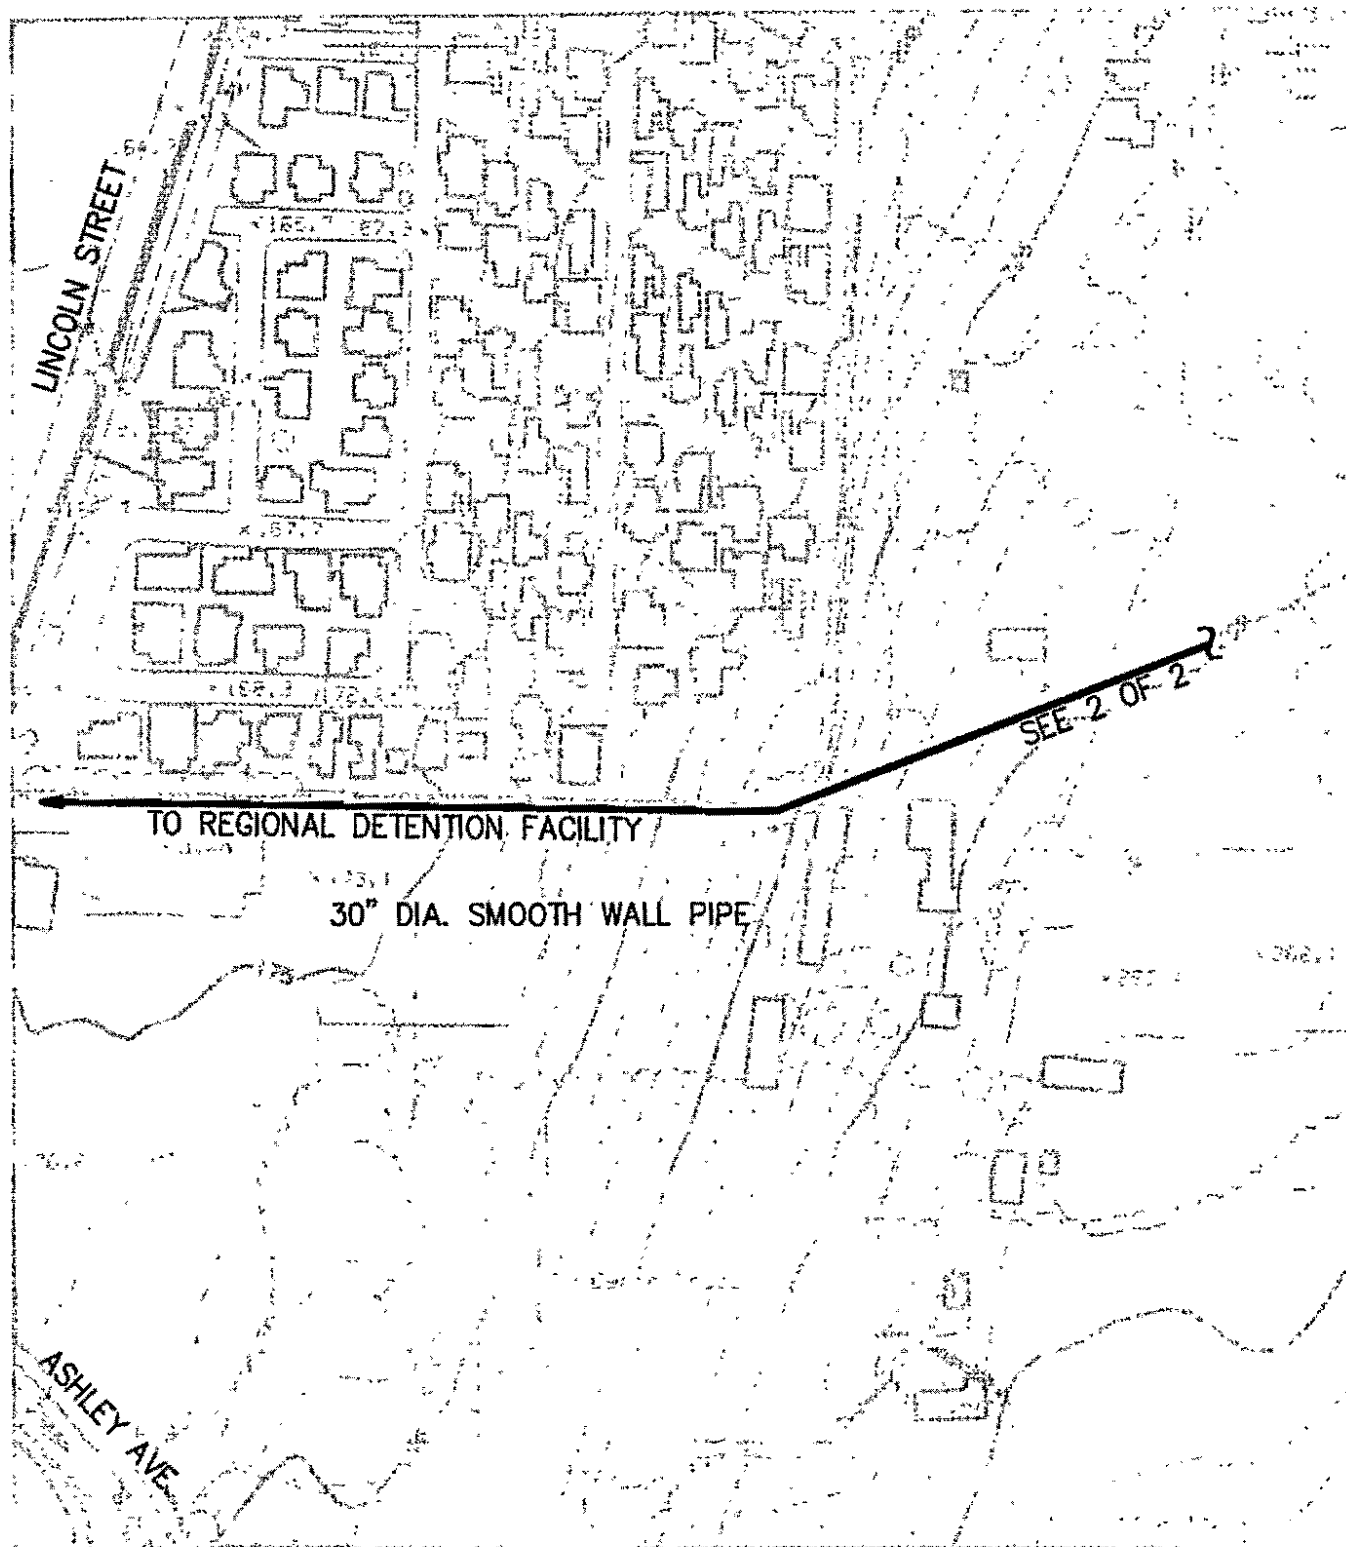
FIGURE  
LC.2  
1 OF 2  
10/22/93

SCHEMATIC  
LINCOLN CREEK  
PROBLEM NO. 7

The recommended solution is Alternative 12, increase the pipe diameter (Figure LC.3). This can be constructed in conjunction with the development of the site, it will not be included in the Capital Improvement Program.
