Physical Plant Inspection of Comcast Communications in the City of Bellingham, Washington

May 2010

Inspected by
Kramer.Firm, Inc.

**PHYSICAL PLANT SAFETY INSPECTION
OF COMCAST CABLE COMMUNICATIONS
IN THE CITY OF BELLINGHAM, WASHINGTON**

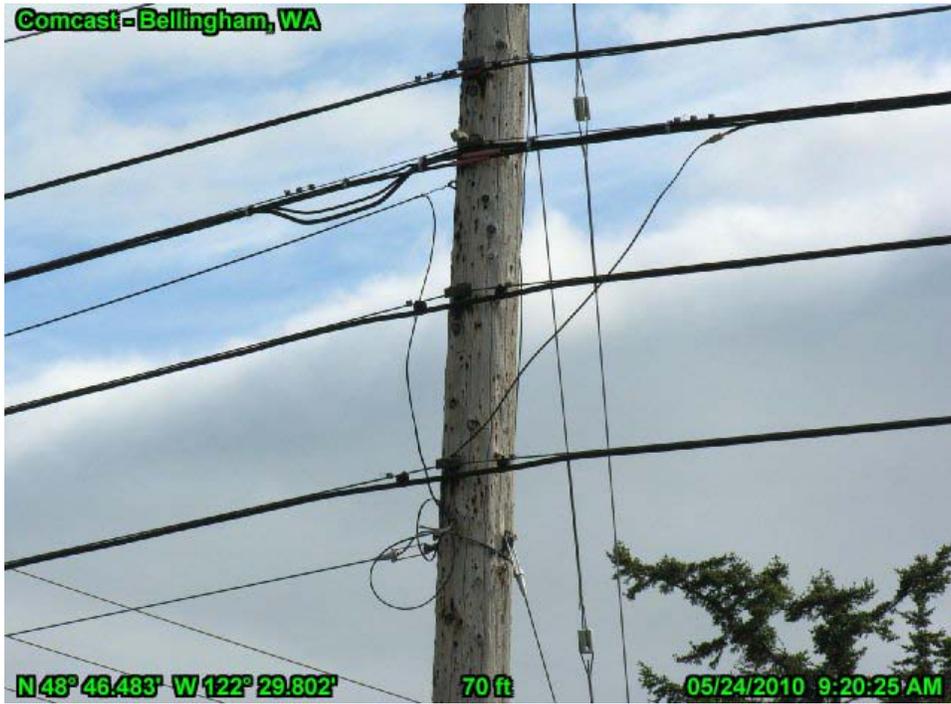
3224 Northwest Avenue. Temporary drop connected to "500 to F" connector. Line is disconnected now. Interferes with climbing space. Needs to be removed.

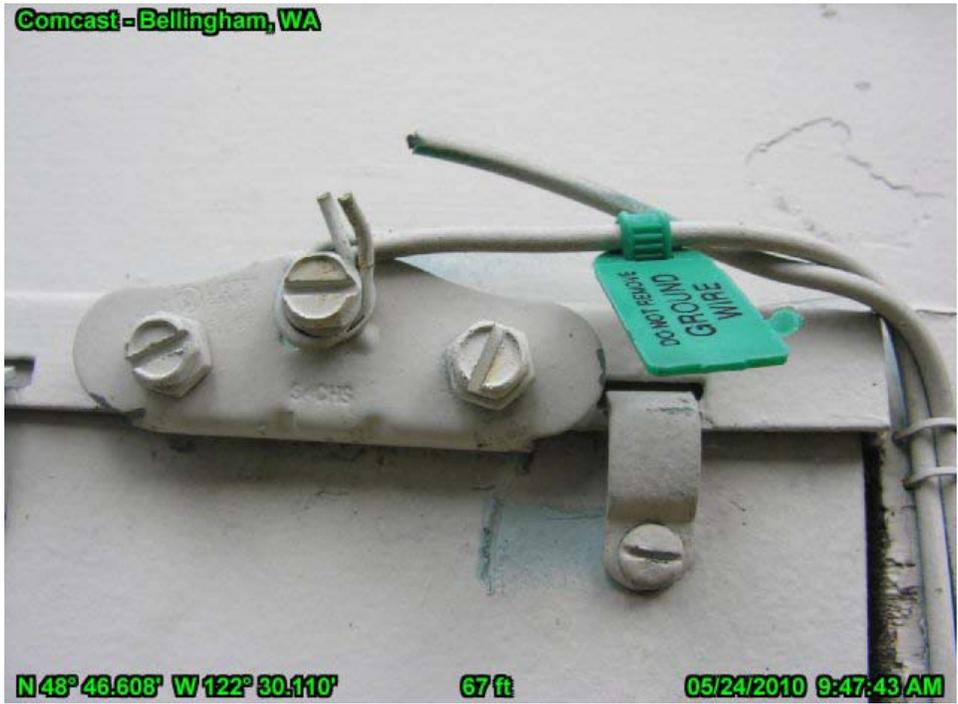
2724 Maplewood Avenue. Ground wire broken at meter clamp.

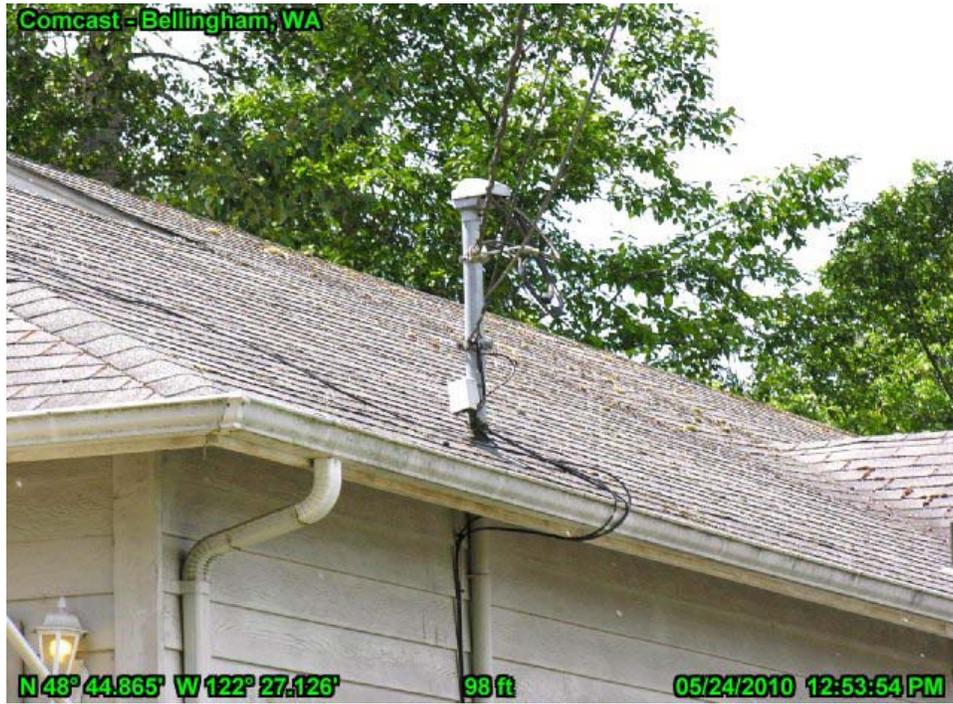
1433 St. Paul.

Cable drop attached to the power mast.

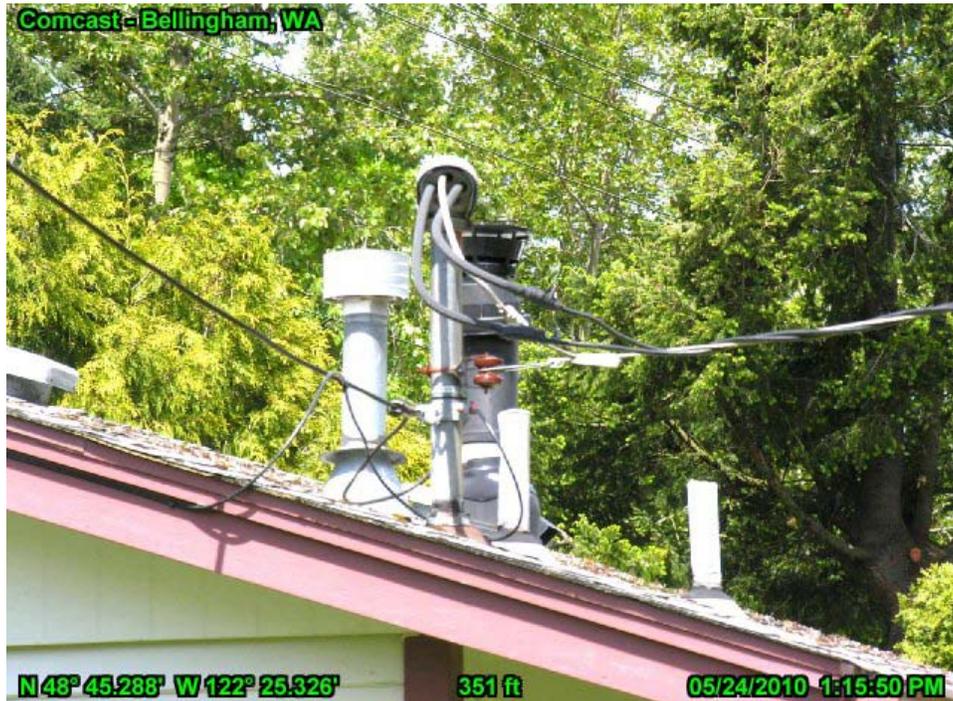
Corner of Electric and Ohio Streets
Cable drop attached to power riser

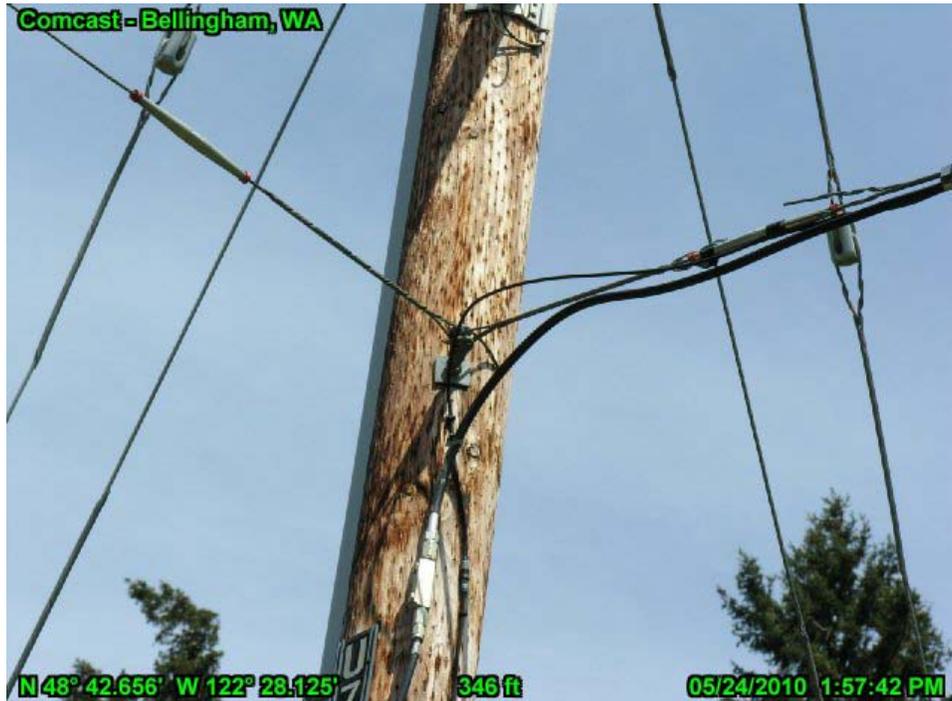
Corner of 37th Street and South Street

Poor pole change out. "Preforms" and deadens not properly attached.
Cables and connections not shrunk. Shrink tubing has slipped down the pole.

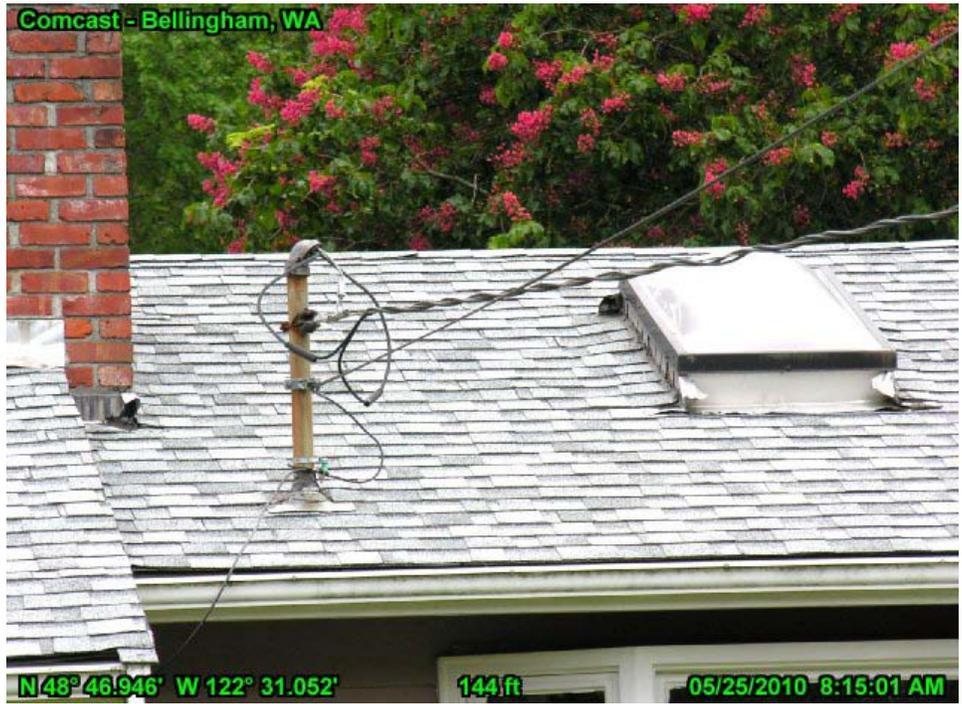
Comcast installers frequently make use of the electrical utility power riser above the roof for making cable drop attachments. The National Electrical Code in Section 820-10(C) prohibits the attachment of any cable drops to an above-the-roof mast containing electrical conductors. This is the most significant and wide-spread violation observed during the inspection throughout all portions of the Bellingham franchise area.

This method of attachment is frequently used in order to obtain sufficient height over a roadway, or because it is an easy and inviting point of attachment. As can be seen in the above pictures, telephone drops are also attached to the masts, and their presence is often interpreted as meaning that it is OK, or a recommended practice. It is not an authorized point of attachment, and in these cases, both utilities are in violation of the National Electrical Code.

As can be observed, this practice often violates the required separation from the power drop and places installation personnel in a dangerous position as they try to work in close proximity to the power conductors.

3218 McCleod Rd.
Cable drop attached to the power mast

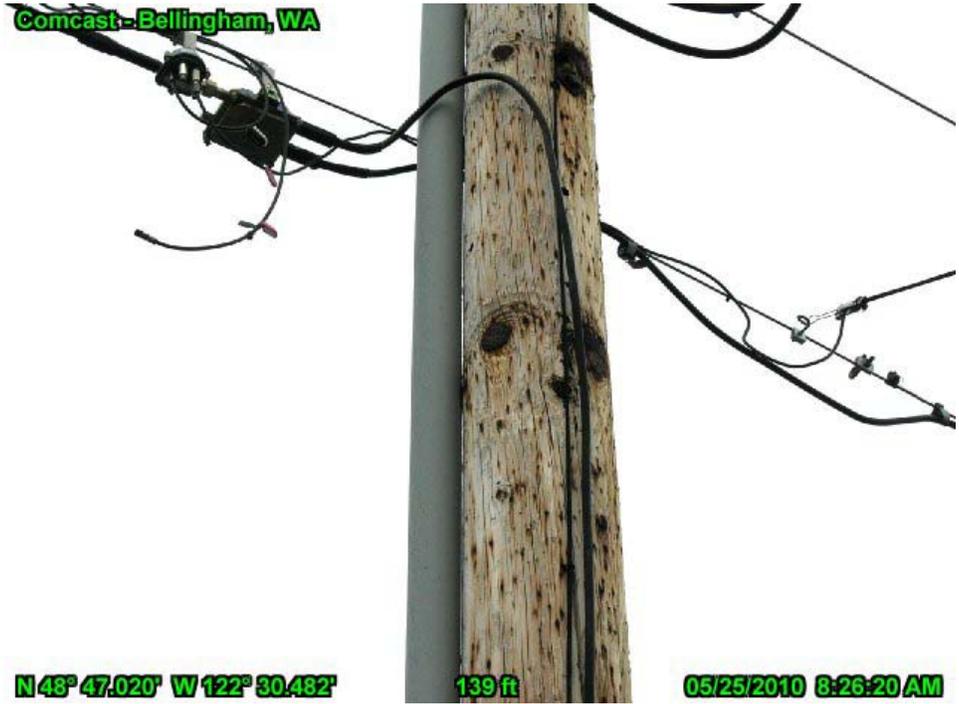
3624 Home Drive
Cable riser not attached to pole.

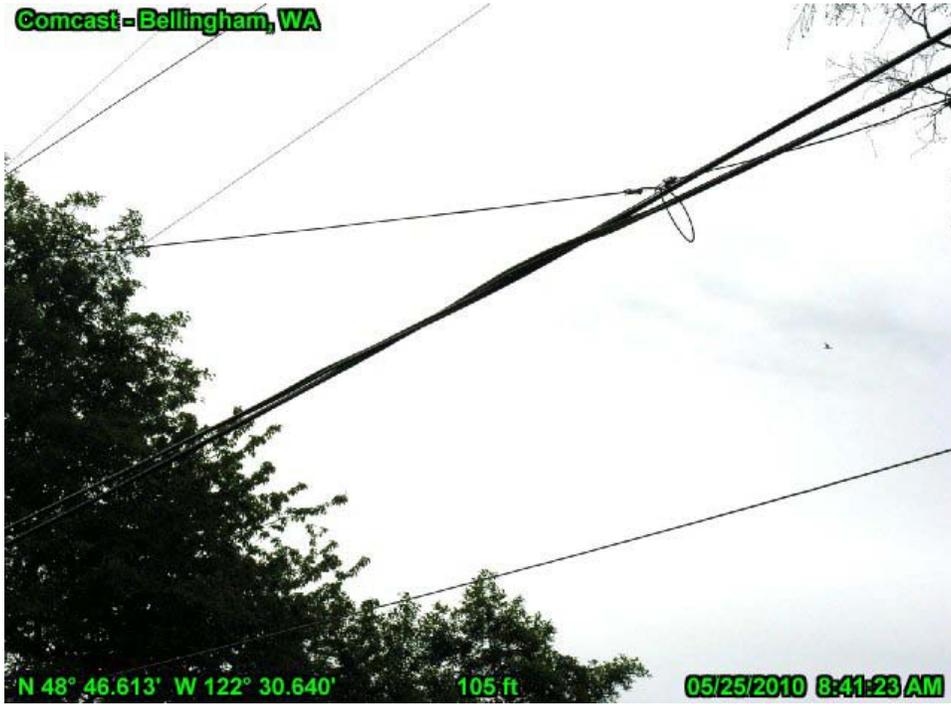
3017 Cottonwood Avenue
Telephone cable wrapped around CATV Cable.

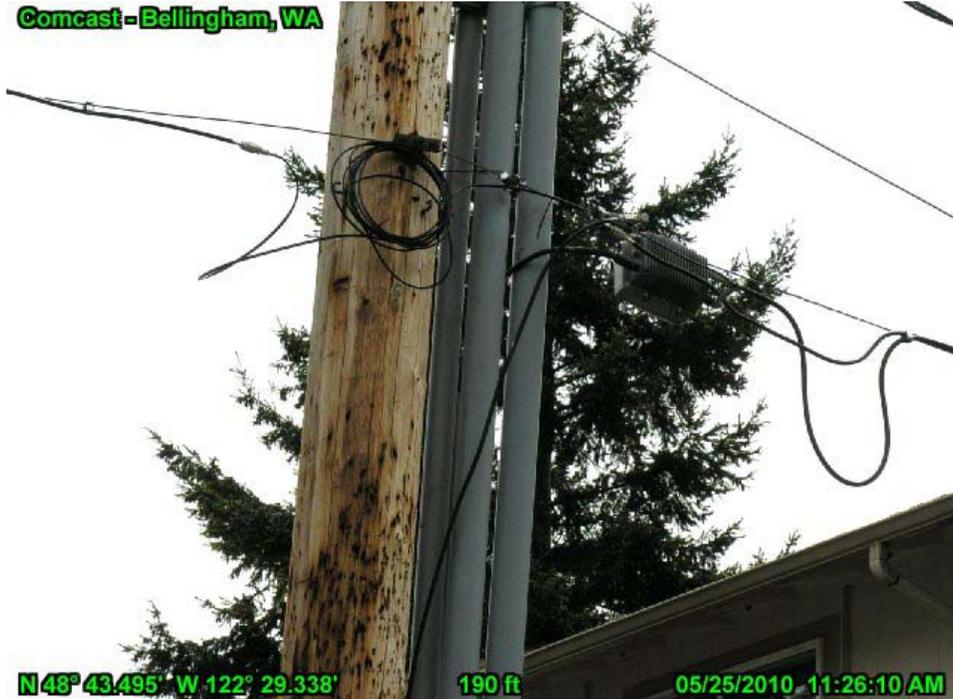
917 to 927 - 22nd Street. Damaged cable sections. Broken cables, lashing, taps.
